**TITLE** Q2 AND BANDIT WING TIP INSPECTION

**CLASSIFICATION** THIS SERVICE BULLETIN HAS BEEN CLASSIFIED AS MANDATORY BY CAA

**APPLICABILITY** ALL Q2 AND BANDIT MICROLIGHT WINGS

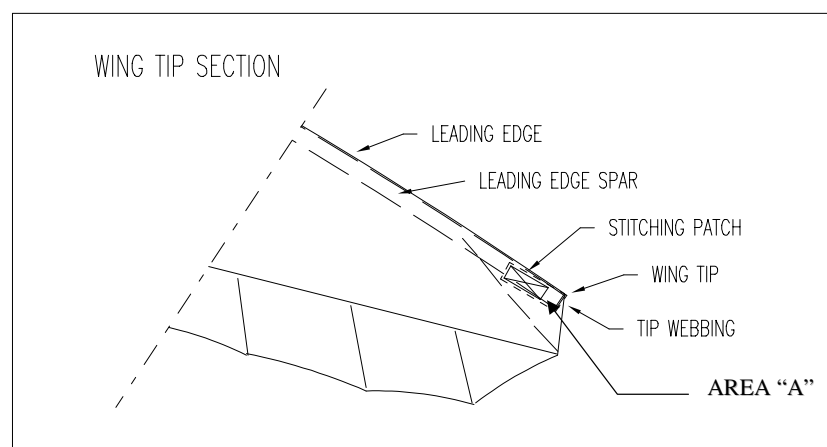
**REVISION** - An incident has occurred following take-off, where a microlight flown dual with a Q2 wing had a tip webbing detach after 970 logged hours, due to stitch failure. On this occasion the pilot managed to control the aircraft and land safely because the sail, although ripped almost through, was retained by the washout rod.

The sail concerned has been returned to the factory for inspection. It was discovered that approximately 1/3 of the critical first row of stitching had also failed on the opposite wing. It was also found by test that the stitching strength had degraded considerably due to the action of UV light. It was noted that there was no deformation of the stitch holes on the failed parts, showing the stitch strength was low. The seam on the non-failed wingtip could be easily peeled apart by hand. The blue colour of the leading edge mylar had faded on the top surface, also showing UV light exposure.

Each tip attachment seam must be inspected for broken stitches, particularly in the peel-loaded areas "A" where the tip webbing leaves the sail. The inspection must be carried out before further flight.

The sail tip attachment must be oversewn and ultra-violet light protection patch added as per drawing SW90087 issue F sheet 6 within the following times:

- a) Before further flight if there are more than 2 broken stitches in area "A" or
- b) Within the next 25 hours if the wing has flown more than 500 hours or has been exposed to daylight for more than 1500 hours or
- c) Within the next 25 hours if there is noticeable fading of the leading edge colour.

If the wing is less than 500 flying hours/1500 hours daylight old and there is no stitching damage or obvious leading edge colour fading, then only the ultra-violet light protection patch must be added, within the next 25 hours.

The patch is supplied in white as standard, with self adhesive tape. Colours that match the leading edge mylar may be available on request. It must be fitted so as to cover all the webbing attachment stitching. The critical stitches can still be inspected on the inside where the webbing leaves the sail at the tip attachment. If in doubt, the patch can be carefully peeled off, stitching inspected then the patch replaced.
