**US SAFETY DIRECTIVE NUMBER 127**

**ISSUE 2**

**MODIFICATION M228**

<b>TITLE</b>	CKT exhaust
<b>CLASSIFICATION</b>	The UK CAA have classified this as Mandatory.
<b>COMPLIANCE</b>	All aircraft, Inspection before further flight. At or before the next annual renewal, fit modification M228 or modified exhaust (exhaust serial number 10940809 onwards)
<b>APPLICABILITY</b>	All Quik, GT450 & QuikR fitted with CKT stainless steel twin exhausts. The CKT exhaust serial number is stamped on one end cover plate.

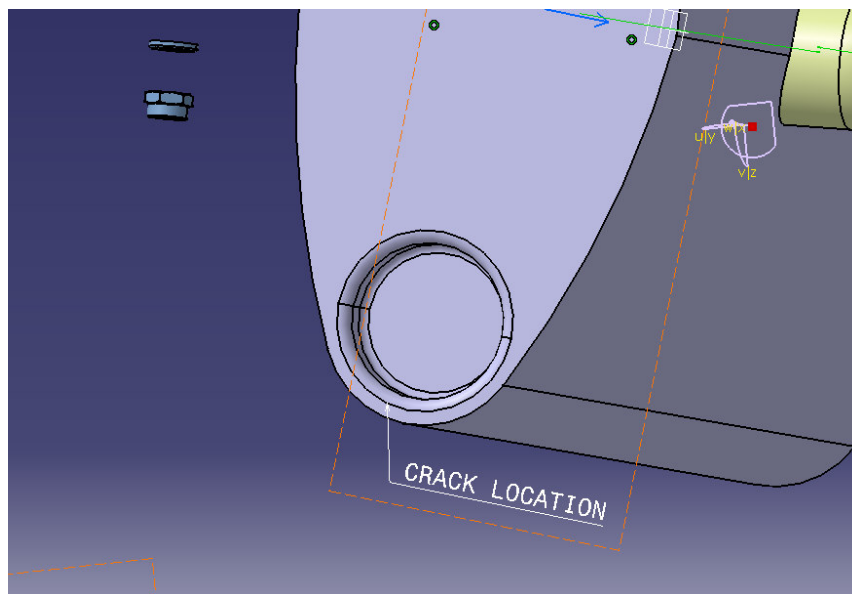
The CKT exhaust silencer has separate front and rear perforated baffle tubes which are welded to the front and rear end cap flanges and plugged with a cap. A fatigue failure of a pair of exhausts serial no. 7811107 has occurred at 125 hours, around the flange edge on the rear end cap, at the weld edge (see fig 1). The baffle tube came free and was ejected from the silencer and hit the propeller. Fortunately this happened at low power on approach, propeller damage was localised and the baffle tube missed the sail; under high power the consequences could be very serious.

The exhausts were fitted to the prototype QuikR (Rotax 912s engine) where failure may be more prevalent due to use of high power settings. Failure has been caused by gas pressure pulses pushing the rear internal baffle plate inwards, causing disengagement of the inner baffle plate from the baffle tube, allowing free vibration of the baffle tube end, leading to failure of the end cap joint.

**Fig 1. Crack location all round weld outer edge**

The problem has been solved by welding on back-keeper plates (modification M228), or by fitting new modified exhausts which have smooth end caps with no baffle tube features.

Before further flight, using good light and a magnifying glass, closely inspect the area around all 4 silencer end caps for cracks, particularly on the weld edges (see fig 1). If cracks are noted, contact P&M Aviation, if possible by email attaching pictures of the damage, hours run, aircraft and exhaust serial numbers. The aircraft must not be flown with cracks in this area.

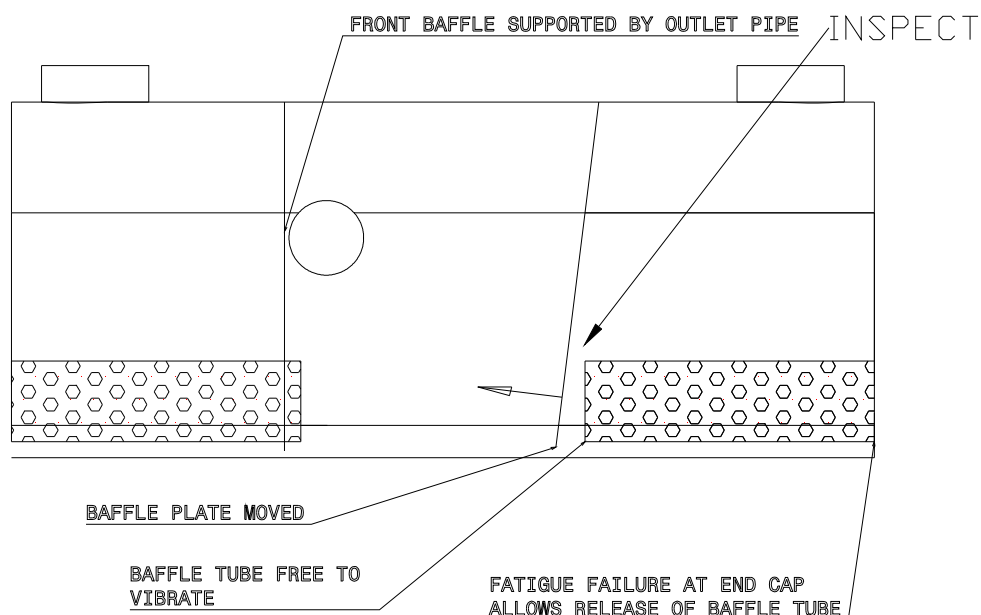
See fig. 2. Through the exhaust header pipe holes, using a torch and mirror, inspect the welded connection between the internal baffle plate and the end of the perforated baffle tube. Try pushing the bottom of the internal baffle plate inwards. If the baffle plate has moved inwards towards the centre of the exhaust and the baffle tube has disengaged from the baffle plate, ***the exhaust must be replaced***. Disengagement is more likely on the rear internal baffle, as the front internal baffle is supported by the outlet pipe.

**Fig 2. Movement of inner baffle plate.**

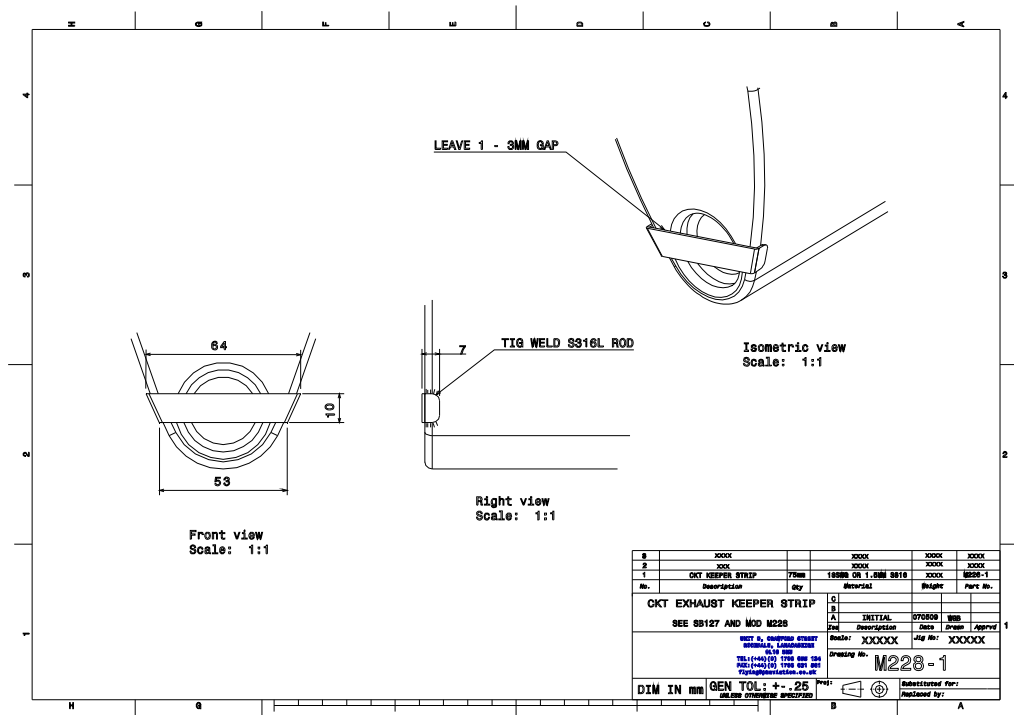
**Fig 3 Exhaust Keeper modification M228**

If the inner ends of the baffle tubes and internal baffles are secure, modification M228 can be carried out (see fig. 3). It provides a backup retainer if the baffle should become loose. Thoroughly clean the area. Do not use any dissimilar wire brush metals and do not mark with graphite or carbon pencils. Weld repair any cracks found using a stainless steel 316L welding rod and TIG process. Fit a 10mm wide x 18swg ( 1.22mm) or 1.5mm S316 strip with 7mm bent edges as shown, weld to the silencer ONLY at the corners, over the existing corner weld. The repair/modification must be carried out by a welder qualified for thin (0.9mm) stainless steel. FAA publication AC43-13-1B is a useful guide to procedures.

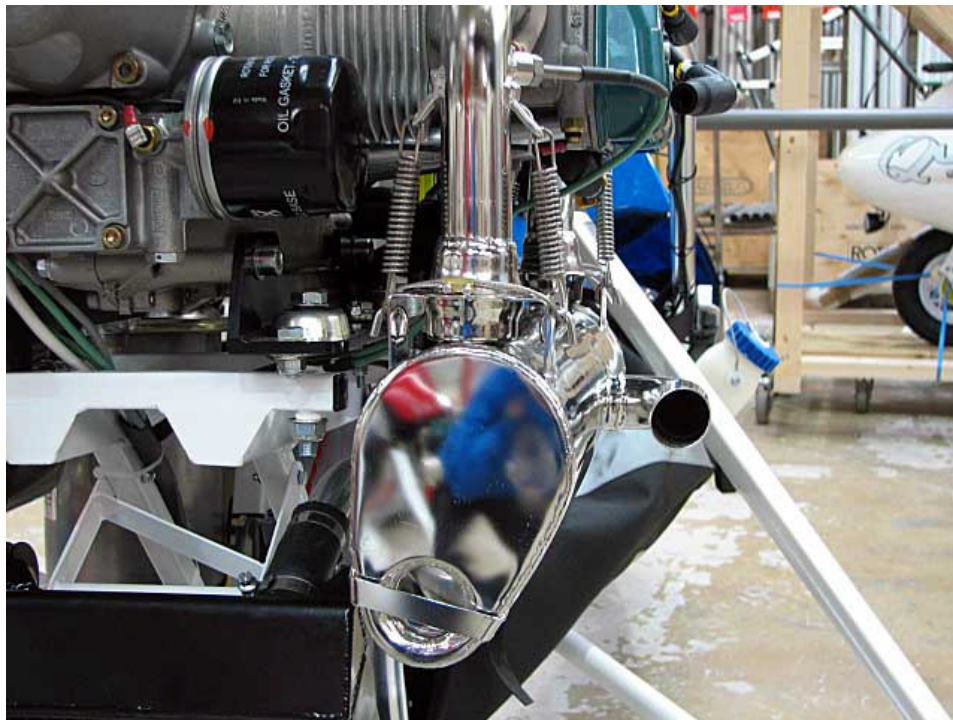
**Fig 4 Exhaust springs and backup cable**

- d) Apply Copaslip or similar high temperature anti-seize compound to the ball joints
- e) Refit the springs, using a cord to fit them. Rocking the can relative to the pipes may help.
- f) Refit the anti-vibration mount using 20mm washer under a new nyloc nut. Avoid twisting the rubber mount.
- g) Refit the backup cables through the springs as shown in fig 4.
