SERVICE BULLETIN NUMBER AX2013

TITLE AX2000 Undercarriage Rotation.

APPLICABILITY Cyclone AX2000 aircraft only.

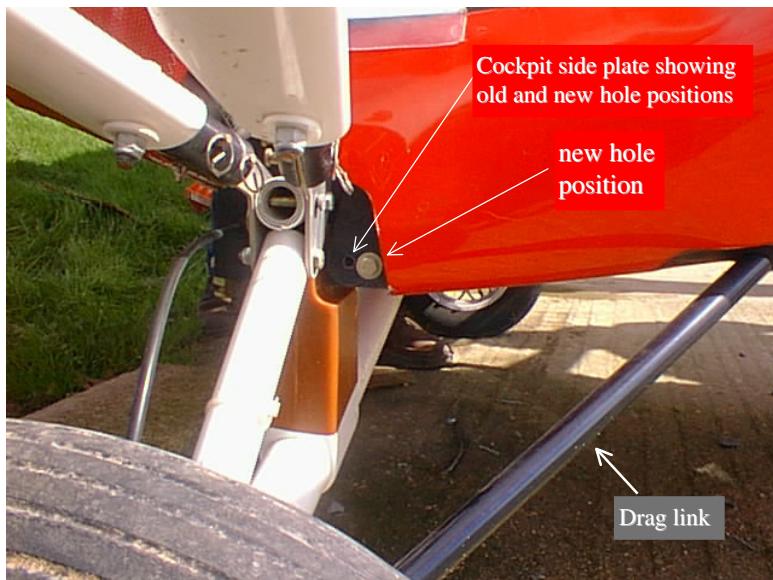
Slight rotation of the main axis has been found to takeoff.

Figure 1: Photograph of AX2000 undercarriage side showing right hand drag link and cockpit side plate.

Rotation of the main axis is achieved by relocation of a hole on the cockpit side plate and shortening of the drag links. See Figure 1.

The drag links need to be shortened by 31.5mm. This alteration can be carried out on existing parts, however it is awkward and untidy. We have therefore decided to offer new drag links at a much reduced price of 50% off the normal price (no dealer margin) for a limited period of 3 months from the date of this bulletin. The part number of the new drag link is 201490.

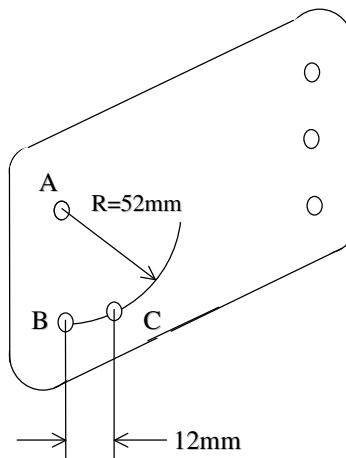
Figure 2: Modified Cockpit side plate hole configuration.

The cockpit side plate can be bought as part number ZPL-133 or modified as follows. Drill a 6.1mm diameter hole (hole C) 12mm towards the inside of the plate (from hole B) on a radius of 52mm from the center of hole A. See Figure 2.
