TITLE	Quik wing control frame top rivets
CLASSIFICATION	The CAA have classified this bulletin as Mandatory.
COMPLIANCE	Before further flight
APPLICABILITY	All Pegasus Quik aircraft up to serial number 8070

The above actions must be entered in the aircraft technical log "Service Bulletin 116 issue 2 top knuckle rivets inspection" and "modification 124, additional top knuckle upright rivets installed" signed by a BMAA or Factory inspector who must be independent of the person who carried out the work.

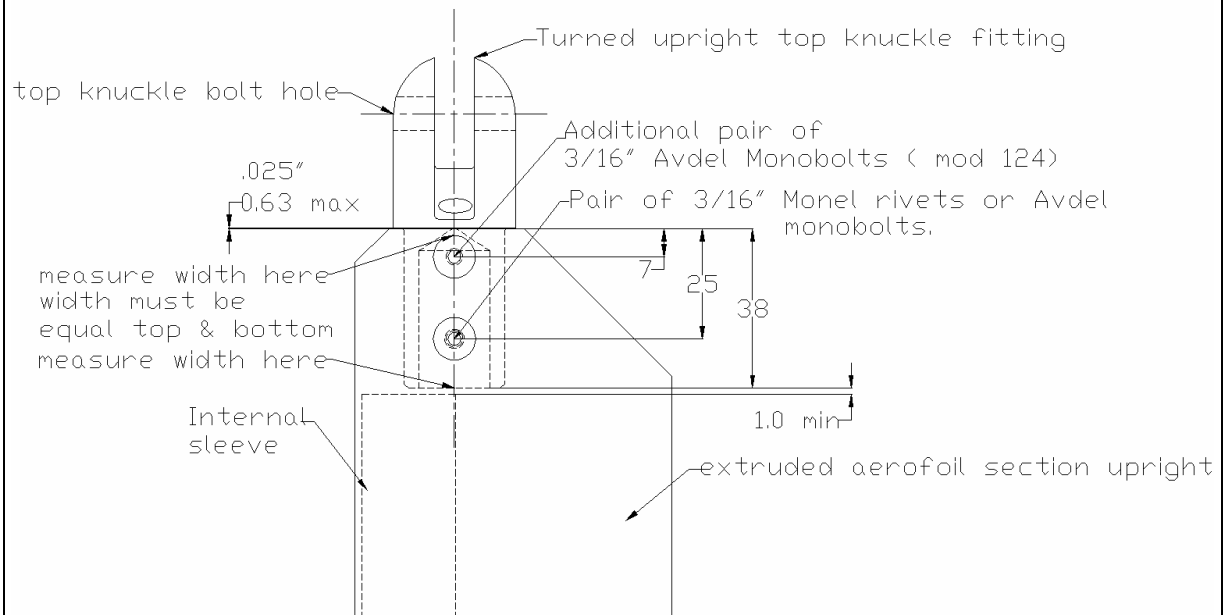
Fig 1 Upright top knuckle joint fitting

Rotation of the top knuckle fitting rearwards about the original two rivets 25mm below the top edge of the upright can occur by buckling in compression if the rivets are worn, if the tube top edge is splayed, or if there is enough gap between the upright top edge and the shoulder of the turned fitting. If the fitting rotates, the rivets may not hold the joint together, with serious consequences.

A) Ensure that there are two Avdel domed head steel monobolt rivets, Mainair part no. FR-006-002, installed 7mm from the top edge of the upright tube, on the centreline of the knuckle fitting. The rivets must be installed squarely and be tight, with the Avdel core no more than flush with the top and with the retaining burr formed in the head. No other rivet type is acceptable here. They must be installed in the correct positions to a tolerance of +- 1.0mm.

B) Ensure there are two more rivets 25mm below the top surface of the upright tube, which must also be installed correctly and be tight. These may be Monel (nickel alloy) pop-type hollow rivets or steel Avdel rivets. Aluminium rivets are not acceptable.

C) Grasp the top of the upright and move the knuckle forwards and rearwards, feeling for rocking or rotating movement of the top knuckle fitting in the aerofoil tube, signs of fretting or loose rivets.

D) Using a feeler gauge, ensure any gap between the upright top edge and the fitting shoulder is no more than 0.63 mm (.025") The surfaces must not be burred, worn or distorted.

E) Using a vernier calliper, measure the width of the upright extrusion 38mm below the top edge. Lock the caliper at an easy sliding fit. The locked caliper must slide as easily, close to the top edge of the extrusion, i.e. there must be no measurable splaying of the end of the extrusion.

F) Ensure that the internal upright stiffening sleeve, which may be installed in the nose of the aerofoil extrusion or in line with the turned fitting, does NOT butt against the fitting. There must be a gap of at least 1mm between the sleeve top edge and the fitting.

2) If there are no Avdel (solid core flush with domed top) rivets applied 7mm below the top surface of the aerofoil tube, then modification 124 has not been carried out. Remove the uprights and send them, or the whole wing, to the Factory for modification.

3) Where modification 124 has been carried out, the following checks A - F are necessary to ensure it has been done correctly. Inspection must be carried out independently of the person who carried out the work. If found unsatisfactory in any way, mark the uprights as unserviceable and why. Return them to the factory for exchange units, or return the whole wing to the factory for modification and checking.
