**SERVICE BULLETIN NUMBER 122**

**ISSUE 1**

<b>TITLE</b>	Quik wing keel roll bearing bolt hole cracking and other damage.
<b>CLASSIFICATION</b>	The CAA have classified this bulletin as <b>mandatory</b> .
<b>COMPLIANCE</b>	For aircraft with more than 150 hours total time, action must be taken within the next 5 hours. Action must be before further flight following any heavy landing.
<b>APPLICABILITY</b>	All Quik Wings up to and including serial no 8184.

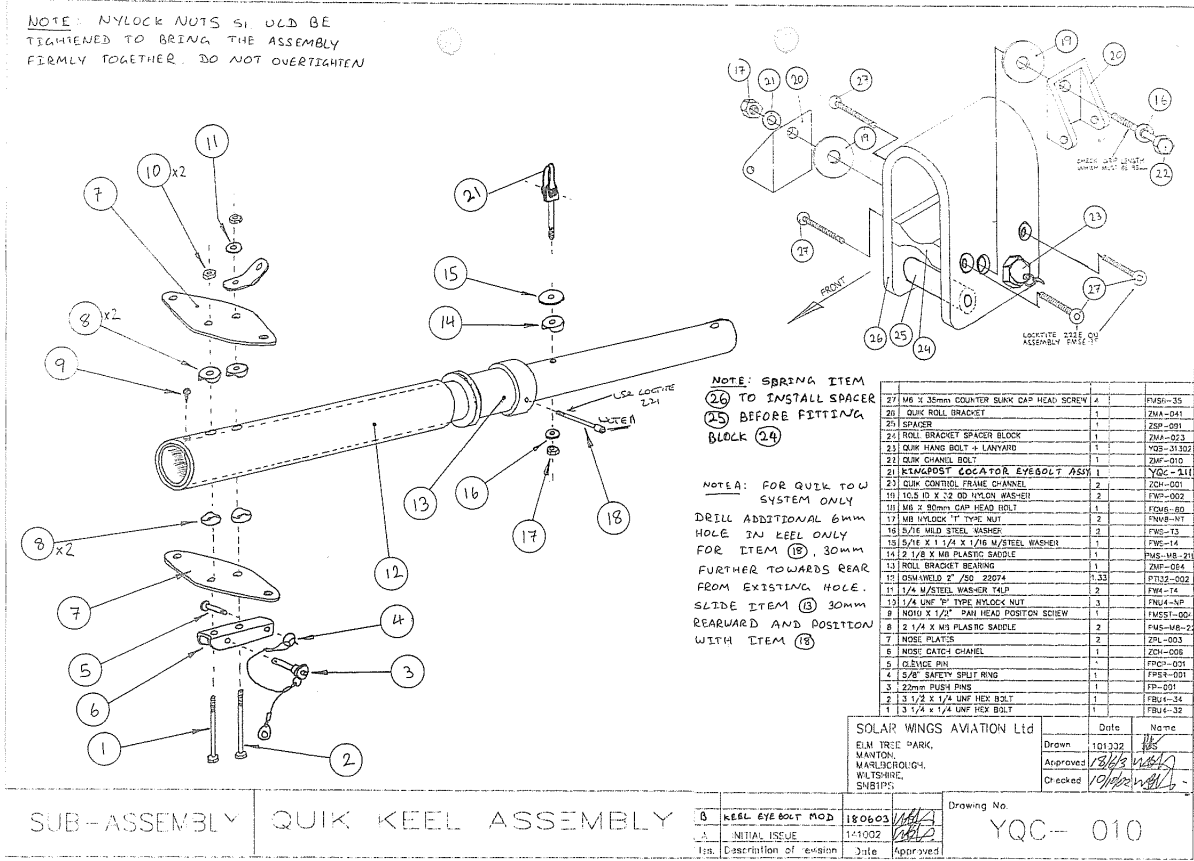
In order to check the wing keel RBBH, the wing needs to be removed from the trike, and the 6mm Cap Head Bolt (item 18, fig1) removed from the Roll Bracket Bearing (item 13, fig1). Remove the nose cone and nose batten. Fold the wing down flat and de-tension it ( see operator's manual). Remove the two keel to noseplate bolts and the self tapping screw nose batten locator. This will enable the keel plastic protector tube to be slid forwards ( the Leading Edge bolts may have to be slackened to aid removal). Remove the plastic protector tube and cut off 25mm from the rear end.

Figure 1 Quik Keel Assembly, the hole is where part 18 passes through the keel tube.

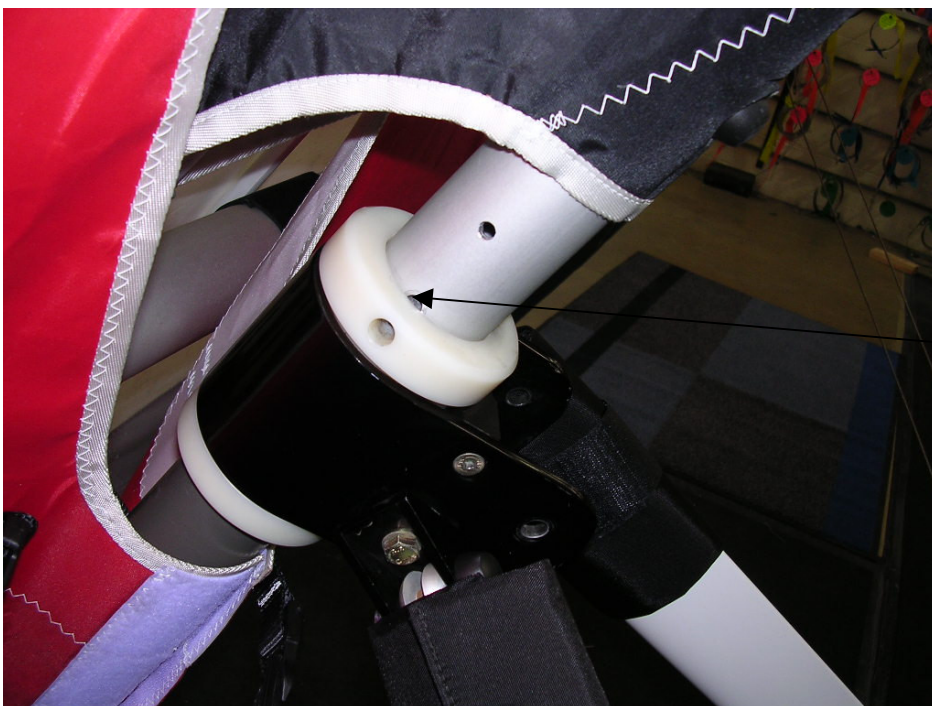
Slide the roll bearing forwards to expose the RBBH area and inspect using a torch and magnifying glass for elongation, fretting or cracks.

Figure 2 Photo Of Wing showing roll bracket bearing slid fully forwards.

Check for cracking

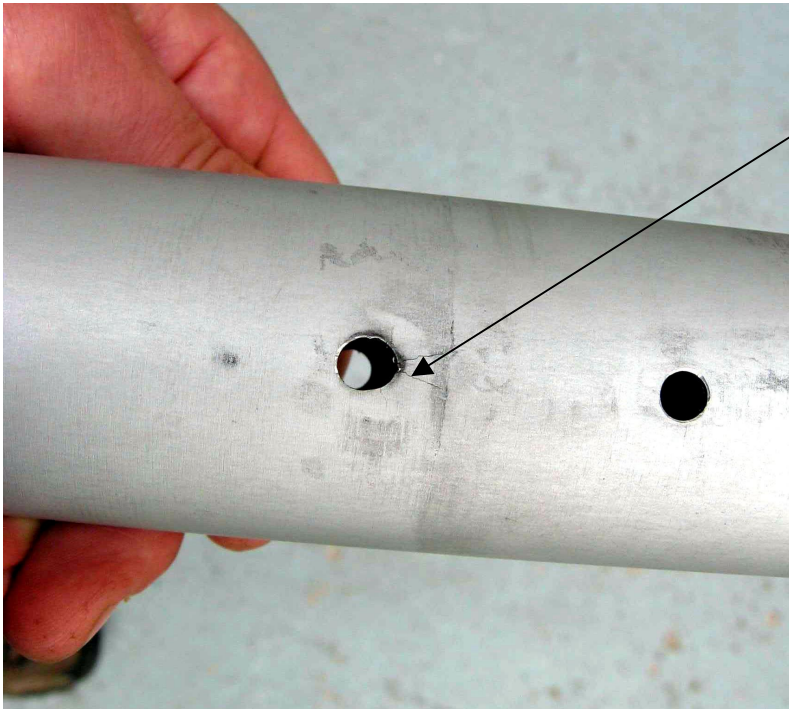
A few Quik wings have been found to suffer from local fatigue cracks in the wing keel at the roll bracket bearing hole (RBBH) where the M6 bolt locates the bearing to the keel. Typically those with cracks have either been training aircraft or subject to a higher than normal number of take offs and landings.

Crack Starts Here Towards Rear  
Of Keel.

*Figure 3*  
Photo Showing Elongation and  
Cracks

If small cracks, elongation or fretting are detected, with the total damage zone confined to a diameter less than 9mm, the keel can be recovered by incorporating modification M139. Please contact the factory to arrange for the wing/keel to be returned for modification. If more damage is found then the wing keel will need to be replaced with a genuine new factory part. Keel replacement can only be carried out by either factory personnel or experienced wing service centres.

P&M modification M139 has been introduced to reinforce the RBBH area with a 3/8" (9.525mm) interference fit bush tube and additional inner keel sleeve. A damaged area up to 9mm diameter is therefore removed completely. **The keel modification can only be carried out by the Factory.** After fitment the keel must be inspected as part of the existing Quik maintenance manual schedule.
