**SERVICE BULLETIN NUMBER CT 125 including MODIFICATION M186
ISSUE 1 PAGE 1 of 6**

TITLE	Fuel System
CLASSIFICATION	The CAA have classified this bulletin as Mandatory.
COMPLIANCE	Fuel flow check before further flight. Modify system within 25 hours or 6 months, whichever is earlier.
APPLICABILITY	All UK registered CT2K aircraft.

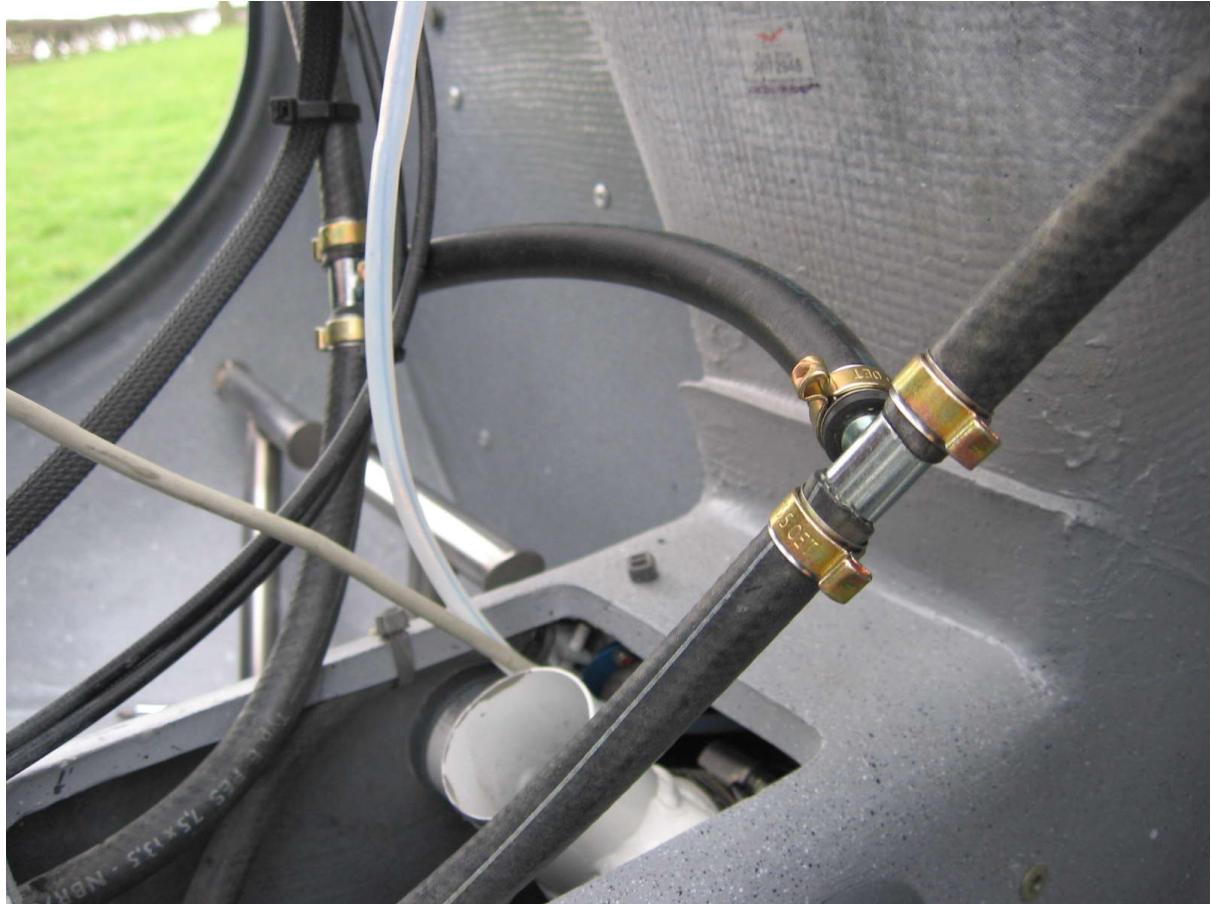
Fig 1 Tee pieces installed approximately 100mm above the top of the tunnel.

- 2.0) Remove central console panel upper section. For improved access, remove both instrument panels.
- 2.1) Clamp off the feeds from the two wing tanks.
- 2.2) Cut the two tank feed pipes approximately 100mm above the top of the fuselage tunnel and fit 2 tee pieces with a link tube between them (see fig 1).
- 2.3) The fuel tank vents must be replaced with vent caps having square cut bottom edges, so as to create the same pressure at each tank vent, as in fig 2.
- 2.4) The fuel tank selector placard must be replaced with the type shown in fig 3.
- 2.5) Check fuel feed and valve function as in (1) above, test the valve in all 3 positions. Check all joints for leaks.
- 2.6) Check any disturbed wiring etc. is correctly routed and clear of rudder cables.
- 2.7) Refit panels.

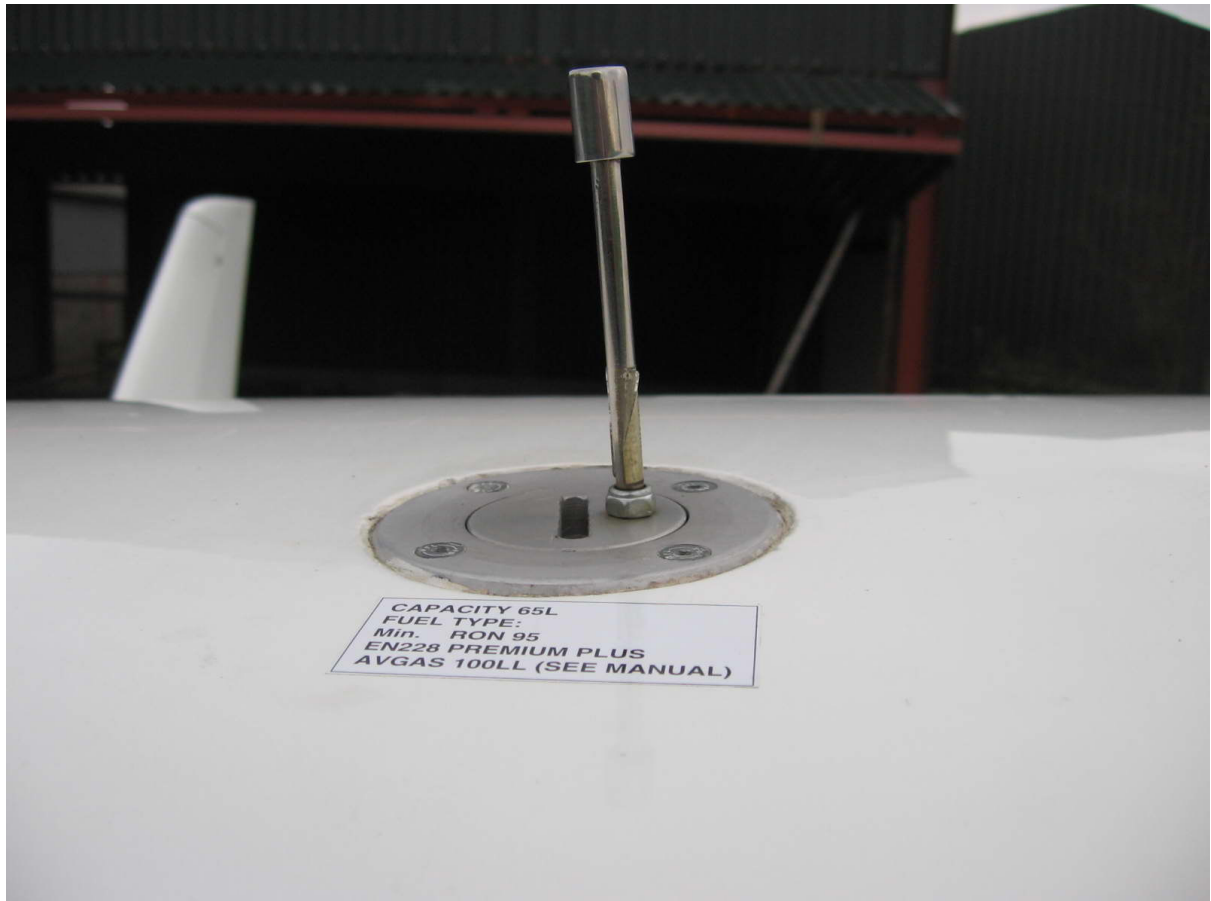
Fig 2, tank vent cap with square cut bottom edge.

Both fuel cap vent bottom edges must be exchanged for those with square cut lower edges. See drawing KA7020060 ASSY MOD M186.

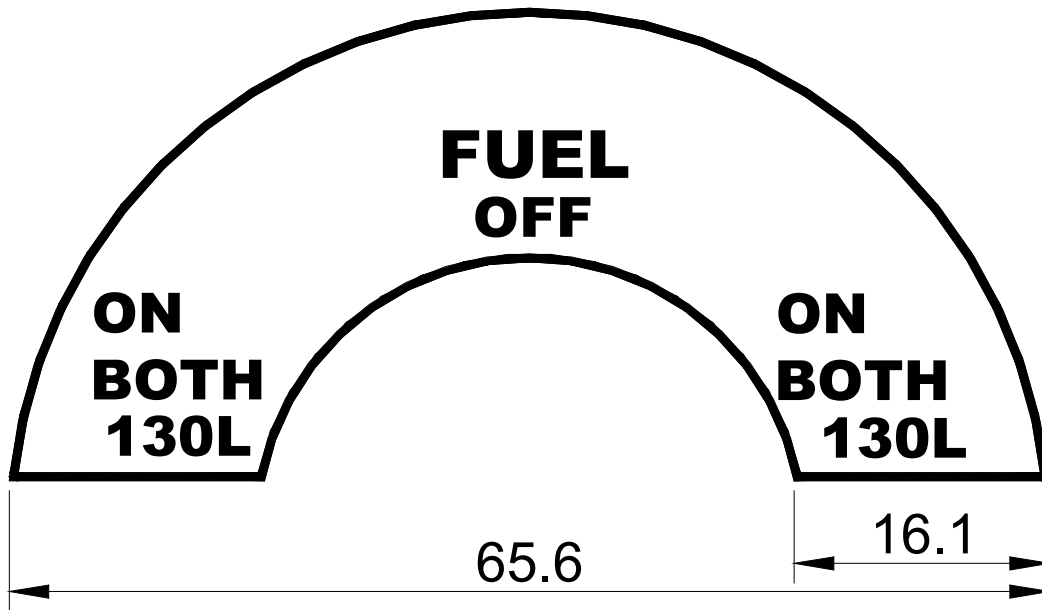
Fig 3 Fuel Selector Placard for Interconnected Tanks
