SERVICE BULLETIN NUMBER SB 131
ISSUE 1 **PAGE 1 of 3**

TITLE	Fuel System, Rohacell dimpling and fuel leaks.
CLASSIFICATION	The CAA have classified this bulletin as Mandatory
COMPLIANCE	Read and ammend operations as directed, append to manual.
APPLICABILITY	All UK registered CT2K and CTSW aircraft.

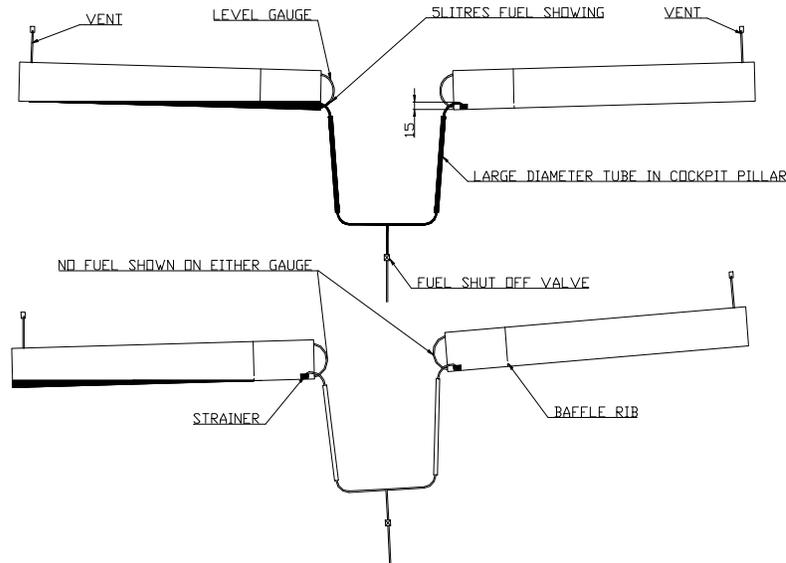
A CTSW ran out of fuel when apparently 5 litres remained in one tank and no fuel indicated in the other. 5 L is marked in red on each level gauge and is the minimum that can be measured. The aircraft has integral tanks, one in each leading edge. There is a baffle rib near the wing root end of each tank. The tank pickups have coarse mesh strainers and a feed pipe with a goose neck 15mm high. The tanks are interconnected on all CTSW and also on the CT2K with modification M186. The tanks are vented by individual vents at the outboard end of each tank. See fig 1 below.

If one tank should empty before the other, in level flight the remaining fuel can still be used up as shown in the top view of fig 1.

However, if the aircraft is in turbulence and/or the aeroplane is flown with sideslip putting the outboard end of the feeding tank low, it is possible for the feed to be uncovered and air to be drawn into the system causing the engine to stop. A standard ground test by Flight Design requires that if 5L is in one tank only and the engine run till it stops with that tank low, a re-start should be obtained within 60 seconds of starter motor turning after the wings are returned to the level. However in flight, that time may not be available before a forced landing has to be set up. Therefore it is not recommended to continue flight unless fuel can be seen at BOTH sight gauges simultaneously.

- 3) It is recommended that the aircraft is landed and refuelled whilst there is still some fuel showing on *both* sight gauges. Fuel levels must be monitored regularly in flight and more frequently as the levels diminish. If flight is continued with no fuel showing on one gauge, the aircraft should be flown in a sideslip with the remaining tank high so as to keep the feed running.
