**SERVICE BULLETIN NUMBER 132, ISSUE 4.**

| <b>TITLE</b> | Sail reinforcement degradation additional test issue 4. |
| <b>APPLICABILITY</b> | Q2, Quik, GT450, QuikR and Quik GTR with X-05 or Technora reinforcement bands. |

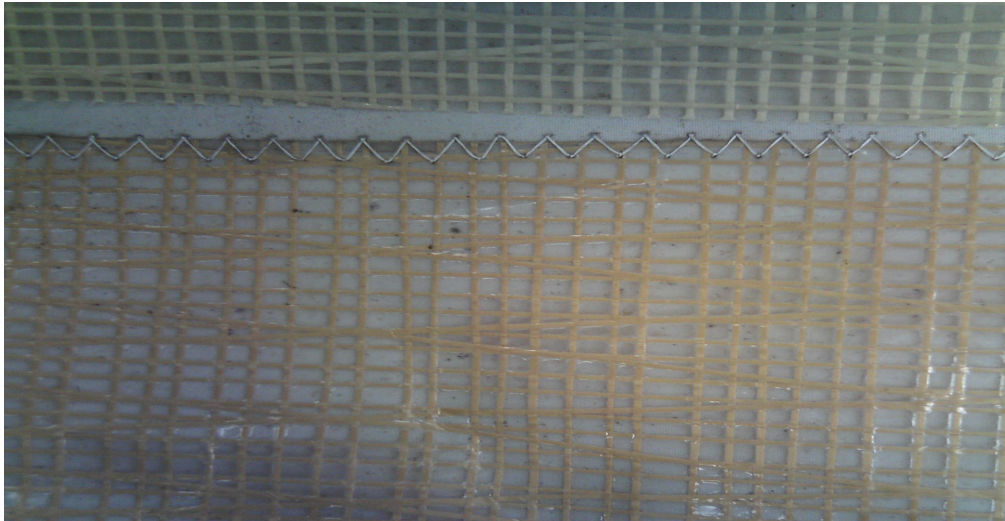
a) Aramid type X-05, which is made of yellow/gold cords woven in a cross pattern with additional diagonal cords sandwiched between transparent mylar films ( see fig 1). This is the type which failed when degraded.

Fig 1, X-05 material. Top strip is new ( bright yellow fibres) Bottom strip is degraded ( gold/brown).

The aramid fibres start life as a bright yellow, which changes to a dull gold/brown as UV degradation develops. It may be possible to see the colour change beneath the area covered by the winglet (where fitted). The Technora is a para-aramid but dyed black to improve UV tolerance.

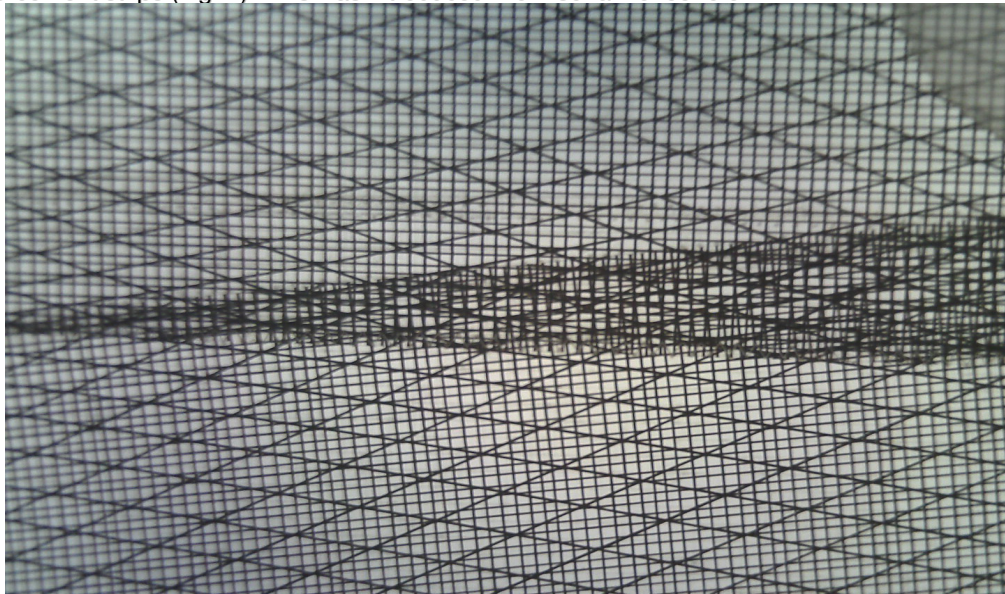
Fig 2. Technora material

b) Technora, which is the same weave pattern as X-05 but with black cords and wider sail reinforcement strips ( fig. 2). This was introduced from serial no. 8526 on.

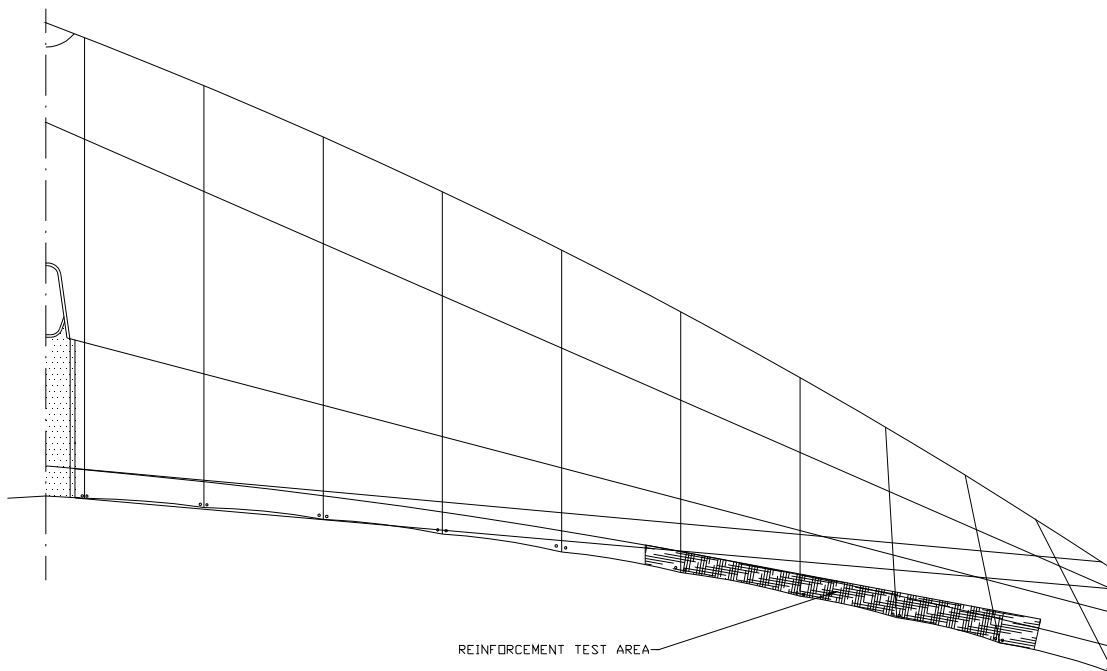
Fig 3. area for reinforcement tests

The test is to be carried out by an inspector, on 2 places on each side of the wing (a total of 4 tests), within the area shown in fig 3. The test is to be carried out with the sail un-tensioned. This can be achieved by removing the 4 tip battens in the test area to ensure no tension remains, if the wing cross tube tension is left applied.

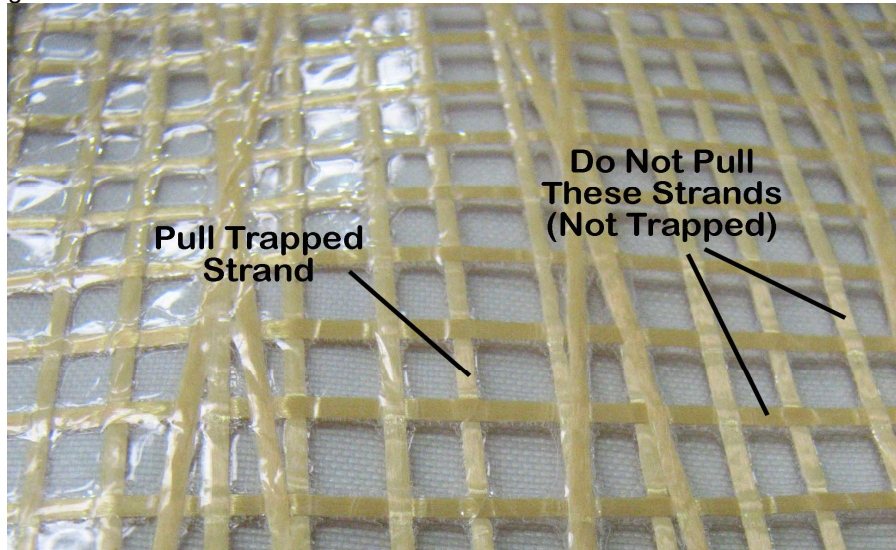
Fig 4 showing the correct strands to pull.

Look for a cord which is woven underneath nearby cords, to avoid pulling one out of the surface as shown in fig 4.

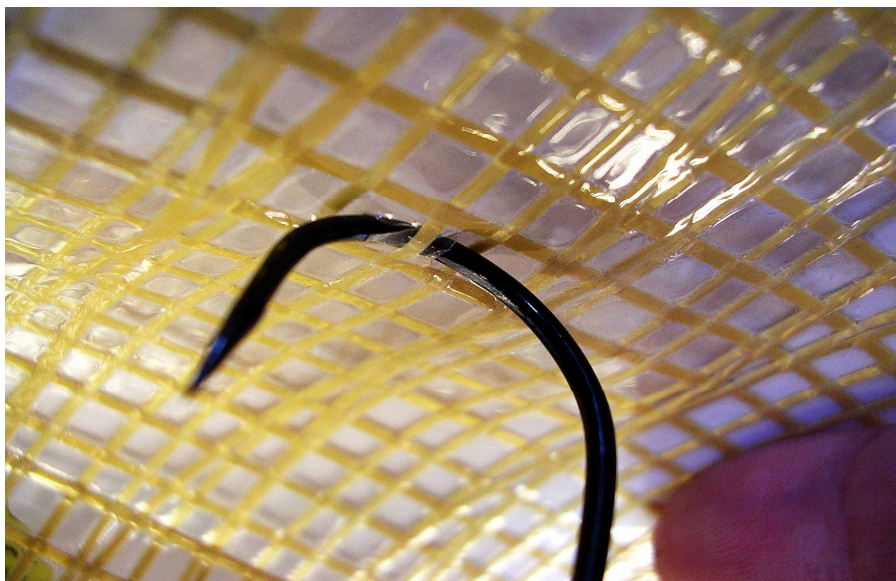
Fig 5 showing hook in position. Note adjacent strands must trap fibre being pulled.

Using an approved test instrument ( consisting of a modified spring balance of 10kg capacity and a 1.5mm diameter smooth hook with a sharp point), carefully capture one cord, avoiding picking up any additional fibres from the adjoining layer. Pull away from the surface, allowing the material to fold as shown in fig 6, gradually increasing the load until the test value is reached. If the cord consistently breaks below 8kgf (Technora Black) or 9kgf (aramid yellow) load then it has failed. Care must be taken as if a cord fails, the hook will easily penetrate the Inspector's skin.

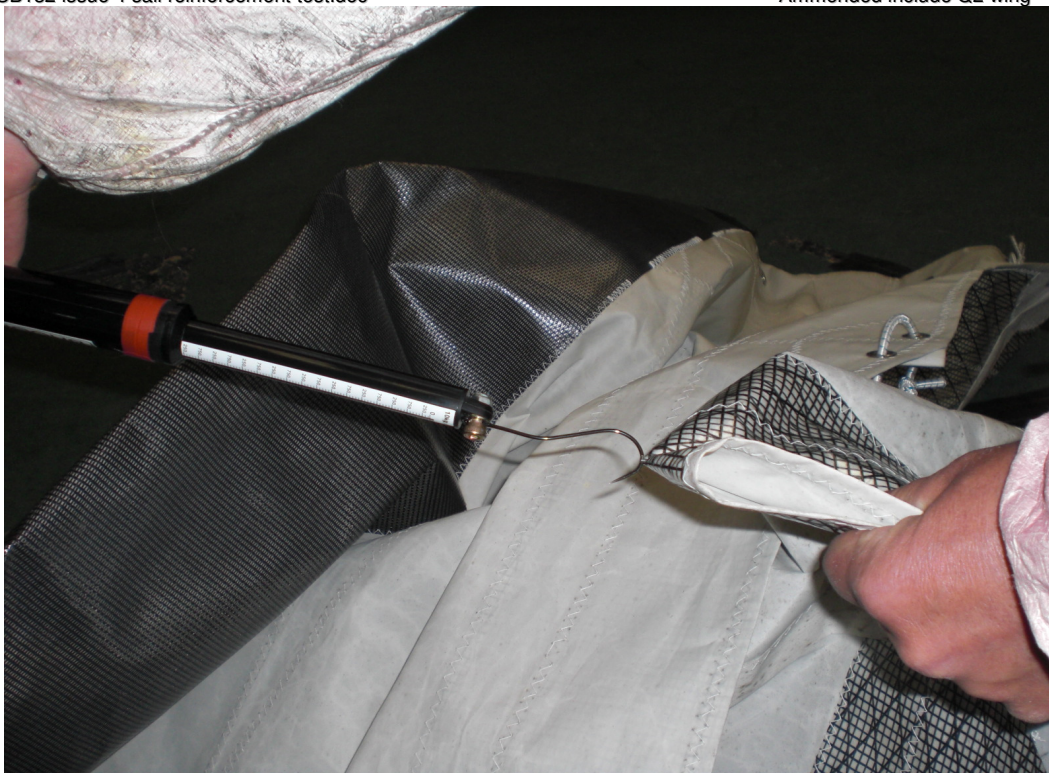
Fig 6. Hook through one spanwise cord which is woven under the surrounding cords as shown. Allow the sail to fold and grasp both surfaces. Pull gradually up to the test load as shown.
