SERVICE BULLETIN NUMBER SB 134
PAGE 1 of 1

TITLE	Windscreen reinforcement.
CLASSIFICATION	Recommendation.
COMPLIANCE	Inspection within the next 5 hours.
APPLICABILITY	All GT450 and QuikR flexwings, also Quik post mod M158 (GT450 type screen)

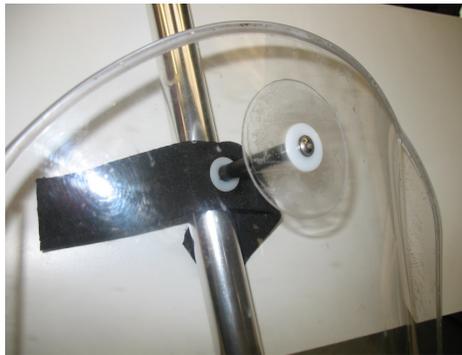
INTRODUCTION
There have been some reports of the windscreen splitting across the top mounting hole. There is little chance of the screen departing the aircraft but it could be alarming for the pilot.

Fig 1. windscreen with reinforcing washer applied to the inner surface.

ACTION:
Inspect the polycarbonate windscreen closely for cracks or crazing, especially around the top mounting hole, the bottom mounting holes and the top and bottom edges of the screen. If cracks are found, the screen must be replaced before further flight. If no cracks are found, the reinforcing disc (minor modification M251) can be applied to the inside surface of the screen as follows:

- 1) Remove the screen from the aircraft and remove the top M5 mounting screw.
- 2) Degrease screen with mild detergent and allow to dry. **DO NOT USE FUEL OR ANY OTHER HYDROCARBON SOLVENT.**
- 3) Peel off the reinforcement disc self adhesive backing film and using the M5 screw to centre the disc, apply it to the screen **inside** surface as shown in fig 1. Press firmly into place.
- 4) Refit the top M5 mounting bolt and nylon washer – if it is a tight fit, relieve the hole with a 5.1mm drill.
- 5) Refit the screen.
