ref SB142Luff Line Attachment Loops

SERVICE BULLETIN NUMBER 142, ISSUE 4.

TITLE	Luff line attachment webbings.
CLASSIFICATION	P&M Aviation have classified this bulletin essential.
COMPLIANCE	For sails over 200 hours airtime, Inspection before further flight.
APPLICABILITY	Pegasus XL- Q, Quasar, Quantum, Quik, Mainair Gemini Flash2A, Blade, P&M Quik, Quik GT450.

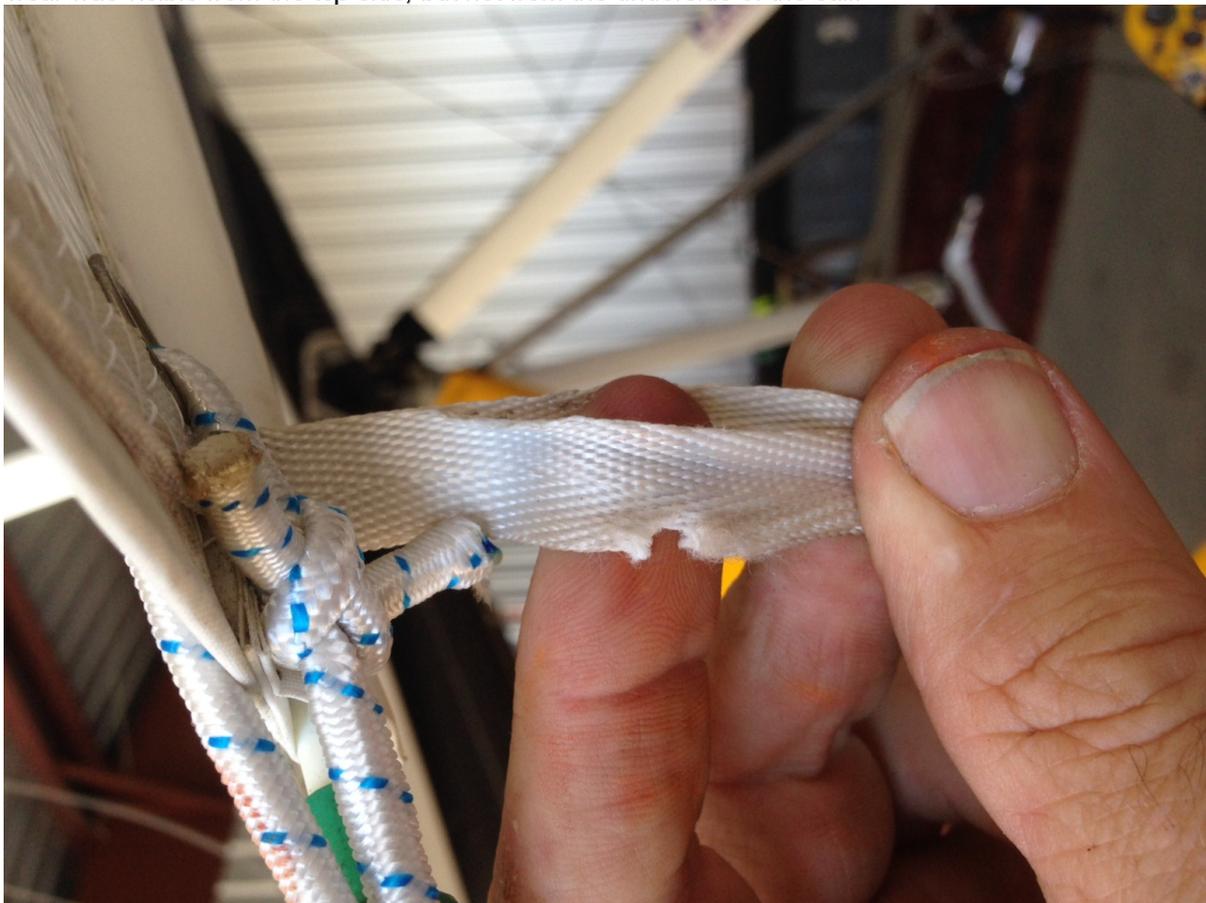
The port inner luff line attachment webbing failed on a GT450 wing with 620 hours airtime during taxiing.

The polyester webbing loop had chafed against the chrome plated brass eyelet. The webbing wear was visible from the top side, but not from the underside of the sail.

Fig 1 example of damaged webbing when removed from the eyelet.

A detached luff line is hazardous as it may go into the propeller. Pitch stability in a steep dive or in turbulence would also be compromised.

Inspect the luff line attachment webbings closely from the **top** and bottom of the sail where it bears against the eyelet. Damage may be easier to spot if the sail trailing edge is raised so as to take the tension off the luff line.

If there is no sign of fraying, the aircraft may continue in service providing the area is closely inspected *from both top and bottom sides* every 50 hours.

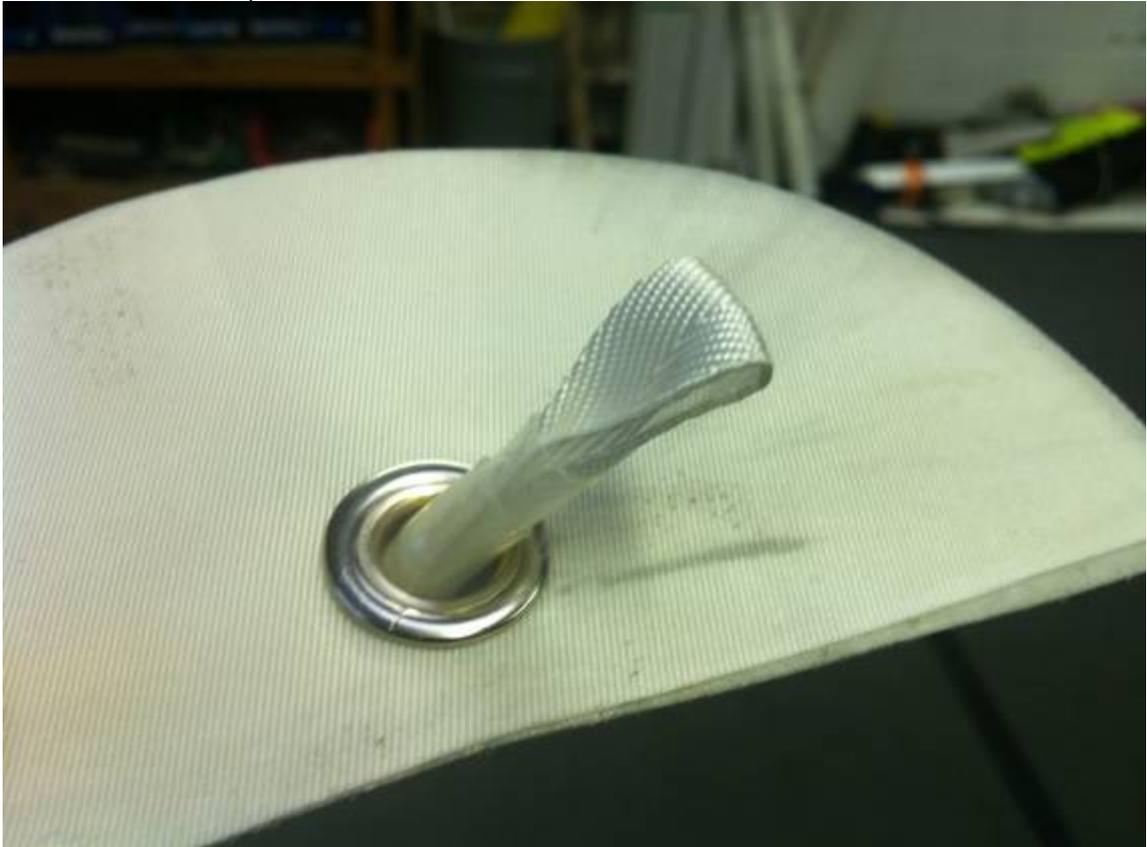
Fig 3 protection by heat shrink tubing.

The webbing may also be protected against further wear by covering it with 2 layers of 9mm clear heat shrink tube (P&M Part PHS6-001). Disconnect the luff line, put a piece of wire (e.g. locking wire) through the webbing, slip the tube over it, push the tube through the eyelet hole and remove the wire. Shrink the first layer down using minimum heat with a hot air gun, then slide the second layer over it, shrink that down. Reconnect the luffline, ensure the clevis pin ring is correctly engaged. All rings may be replaced with a 5/64" X 1/2" s316 stainless steel split pin (P&M part no. FPSP-005) if desired.

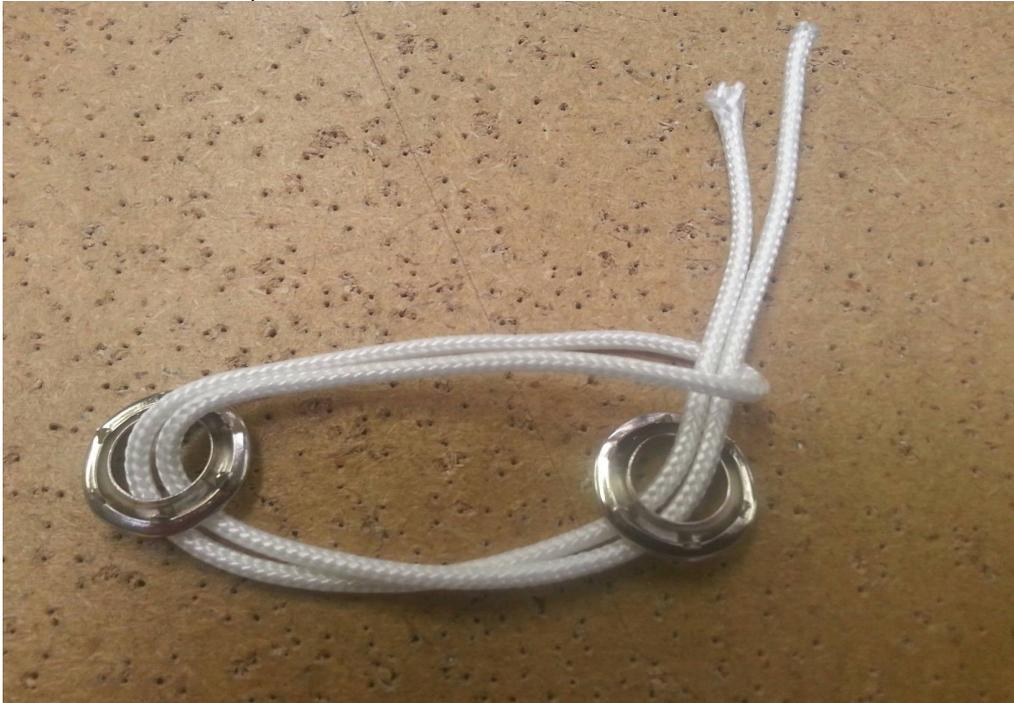
Fig 4 showing the cord loop and the routing through the eyelets. The free ends are tied around the clevis pin.

If the webbing is damaged, it must be replaced before further flight and any ridge removed from the eyelet. Alternatively, if facilities are not available, the following backup load path may be installed:

Using 2.7mm polyester braided cord (P&M part no. VNR-002) form a loop as shown below through the sail eyelets.

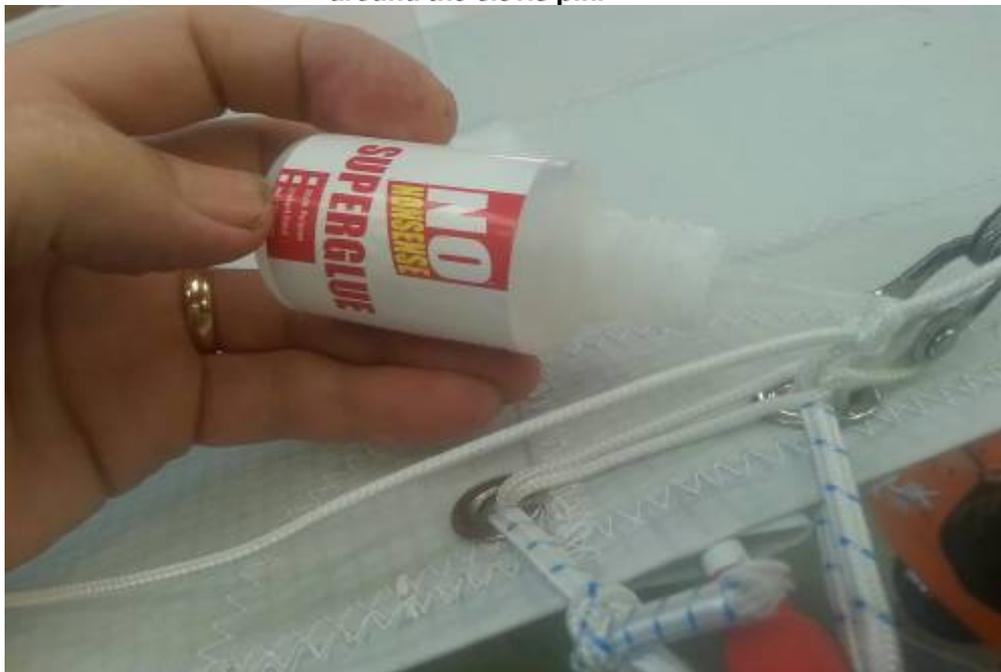
Fig 5 loop the cord through both eyelets, tie the ends off around the clevis pin with a reef knot. Use pliers to get it really tight. Apply cyanoacrylate to the knot (superglue). . Note there should be no slack in the cord.

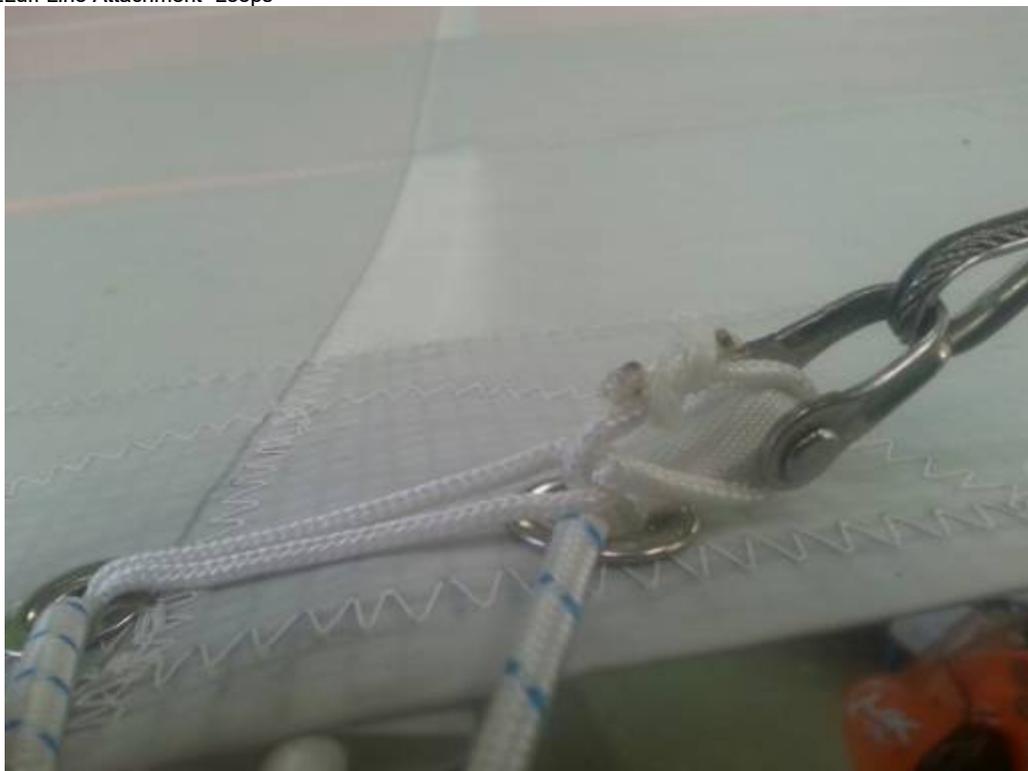
Fig 6 cut and seal the ends of the cord using a hot knife or soldering iron.
