SOLAR WINGS LTD

SERVICE BULLETIN

no. 0032

SUBJECT : Q-Wing and Quasar wing trailing edge

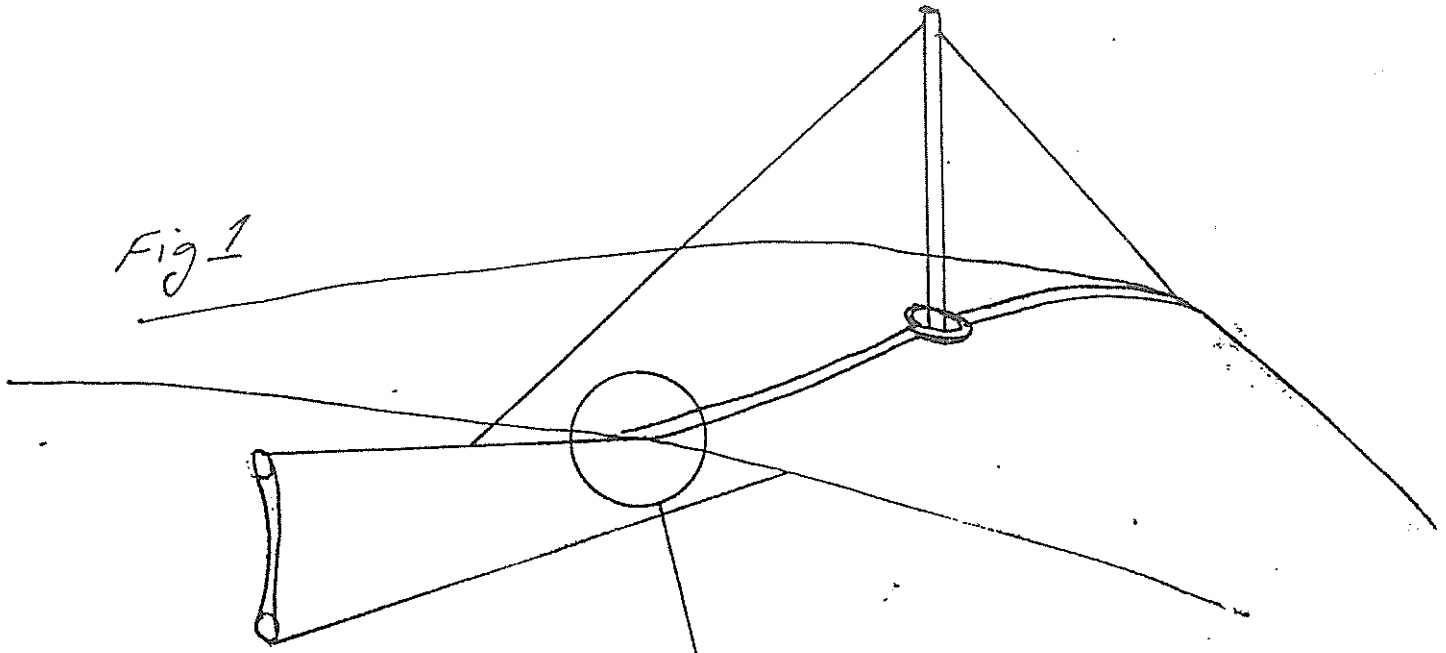
Fig 1

The reason for the failure was abrasion of the centre section seam stitching caused by the fin tube (See attached figs 1-3). The fin tube passes below the sail trailing edge. In the example which failed, the fin tube anodising was worn away in the region of the sail trailing edge.
