SERVICE BULLETIN NUMBER	105	ISSUE 1	PAGE 1 OF 1
--------------------------------	------------	----------------	--------------------

TITLE	Pylon damage on Pegasus Quantum 912
CLASSIFICATION	Advisory
COMPLIANCE	Recommended within 50 hours
APPLICABILITY	All Pegasus Quantum 912 up to S/N 7798

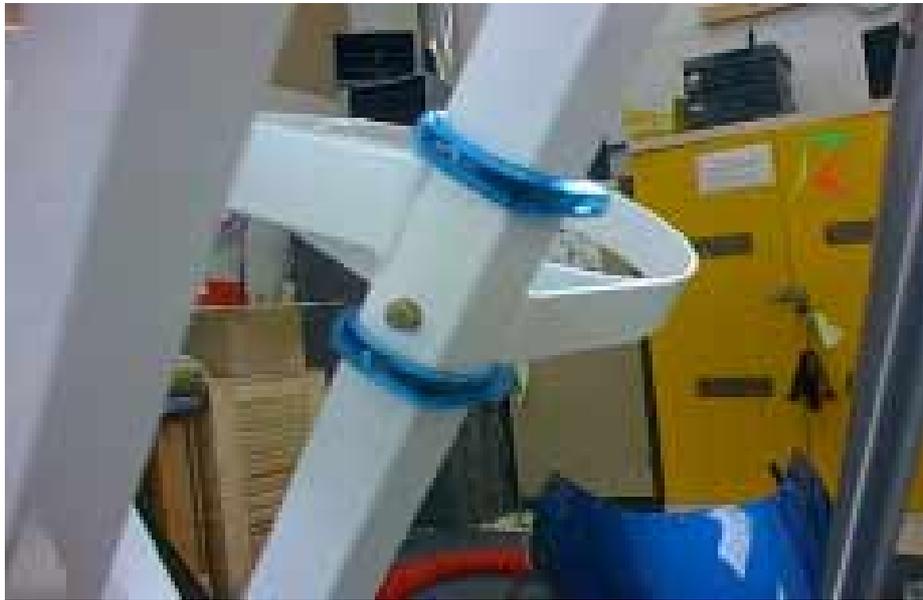
INTRODUCTION
 The Pegasus Quantum 912 has two bolts that mount the oil tank to the engine mounting subframe. If the pylon is not kept straight, it is possible for the forward bolt to scratch the pylon during rigging. The following protection should be applied to prevent further damage.

From S/N 7798 onwards, a countersunk 6mm bolt is used in this location.

ACTION
 Inspect the pylon for damage caused by the bolt head. The pylon is not highly stressed in this area. Damage up to 1mm deep is acceptable. It should be blended out with 300 grit abrasive paper and the area protected with a clear laquer.

Using one of the 90mm long urethane tubes provided, feed one of the ty-wraps through and apply it around the square section tube just below the bolt head. The hose should be positioned so that the mid section (along the length) is placed just below the bolt head. Fit the second tube just above the bolt head. See picture above. The urethane tubes act as buffers to guide the pylon away from the bolt head.
