<b>TITLE</b>	CT door opening due to vibration
<b>CLASSIFICATION</b>	Compulsory
<b>COMPLIANCE</b>	Before further flight
<b>APPLICABILITY</b>	All CT's

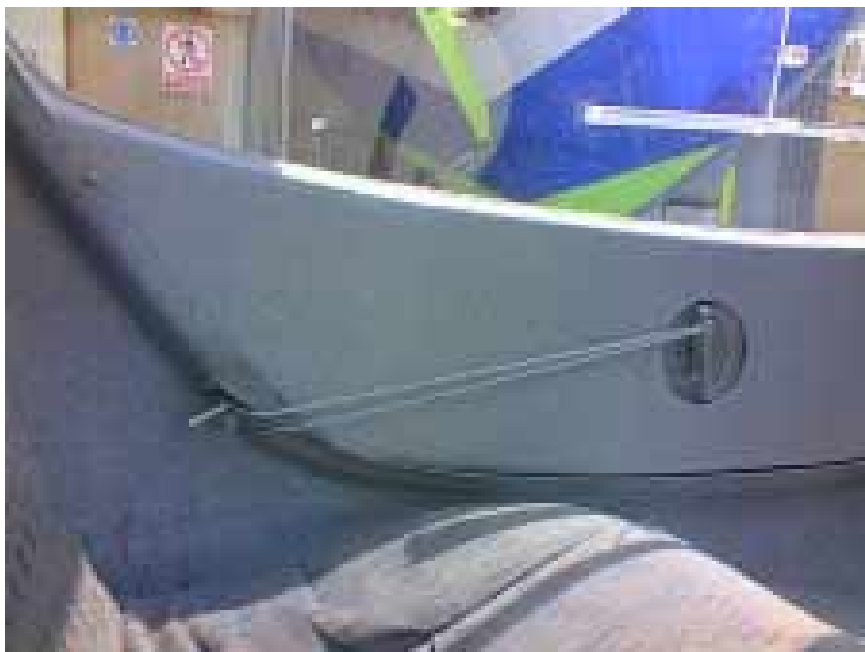
**INTRODUCTION**  
 The left hand door latch as been found to open in flight due to vibration. The following action is to be implemented temporarily until upgraded locking door system is developed.

**ACTION**  
 With the door closed and locked, the door handle has it's bar positioned vertically. In this position a 38cm long loop of shock cord is to be attached at the upper side of the handle bar. Below this point of attachment a tie-wrap is placed around the bar to prevent the shock cord sliding down. Once fitted, the shock cord is stretched and placed around the rear locking pin that protrudes from the door and locates in the fuselage. This prevents the handle rotating during flight and the door coming open. See photo below for more details.
