SERVICE BULLETIN NUMBER 127

ISSUE 2

MODIFICATION M228

TITLE	CKT exhaust
CLASSIFICATION	The CAA have classified this bulletin as Mandatory.
COMPLIANCE	All aircraft, Inspection before further flight. At or before the next permit renewal, fit modification M228 or modified exhaust (exhaust serial number 10940809 onwards)
APPLICABILITY	All Quik, GT450 & QuikR fitted with CKT stainless steel twin exhausts. The CKT exhaust serial number is stamped on one end cover plate.

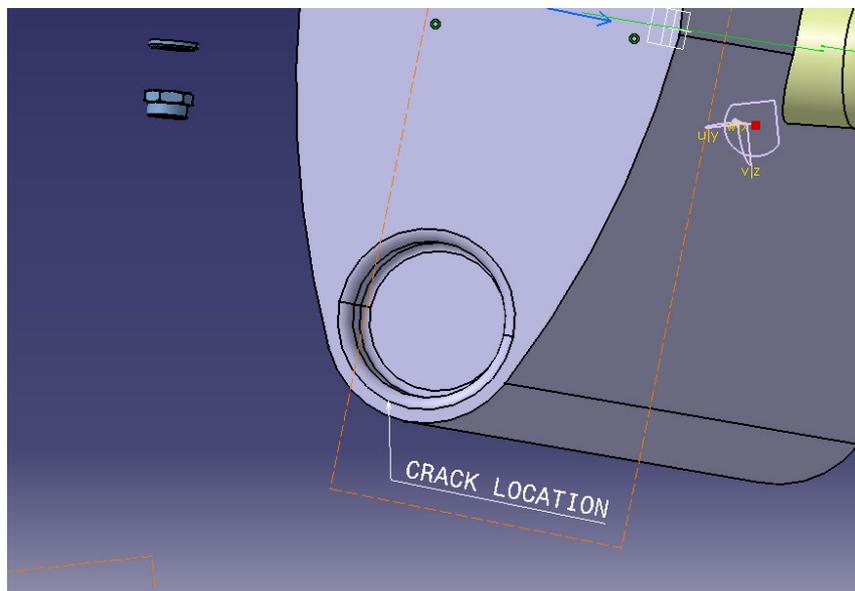
The CKT exhaust silencer has separate front and rear perforated baffle tubes which are welded to the front and rear end cap flanges and plugged with a cap. A fatigue failure of a pair of exhausts serial no. 7811107 has occurred at 125 hours, around the flange edge on the rear end cap, at the weld edge (see fig 1). The baffle tube came free and was ejected from the silencer and hit the propeller. Fortunately this happened at low power on approach, propeller damage was localised and the baffle tube missed the sail; under high power the consequences could be very serious.

The exhausts were fitted to the prototype QuikR (Rotax 912s engine) where failure may be more prevalent due to use of high power settings. Failure has been caused by gas pressure pulses pushing the rear internal baffle plate inwards, causing disengagement of the inner baffle plate from the baffle tube, allowing free vibration of the baffle tube end, leading to failure of the end cap joint.

Fig 1. Crack location all round weld outer edge

The problem has been solved by welding on back-keeper plates (modification M228), or by fitting new modified exhausts which have smooth end caps with no baffle tube features.

Before further flight, using good light and a magnifying glass, closely inspect the area around all 4 silencer end caps for cracks, particularly on the weld edges (see fig 1). If cracks are noted, contact P&M Aviation, if possible by email attaching pictures of the damage, hours run, aircraft and exhaust serial numbers. The aircraft must not be flown with cracks in this area.

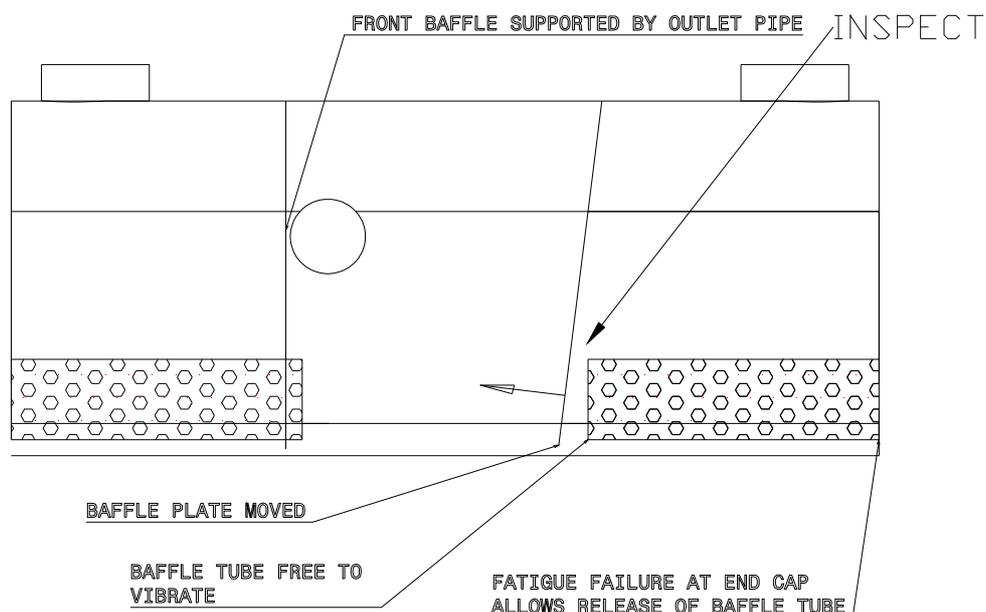
See fig. 2. Through the exhaust header pipe holes, using a torch and mirror, inspect the welded connection between the internal baffle plate and the end of the perforated baffle tube. Try pushing the bottom of the internal baffle plate inwards. If the baffle plate has moved inwards towards the centre of the exhaust and the baffle tube has disengaged from the baffle plate, ***the exhaust must be replaced***. Disengagement is more likely on the rear internal baffle, as the front internal baffle is supported by the outlet pipe.

Fig 2. Movement of inner baffle plate.

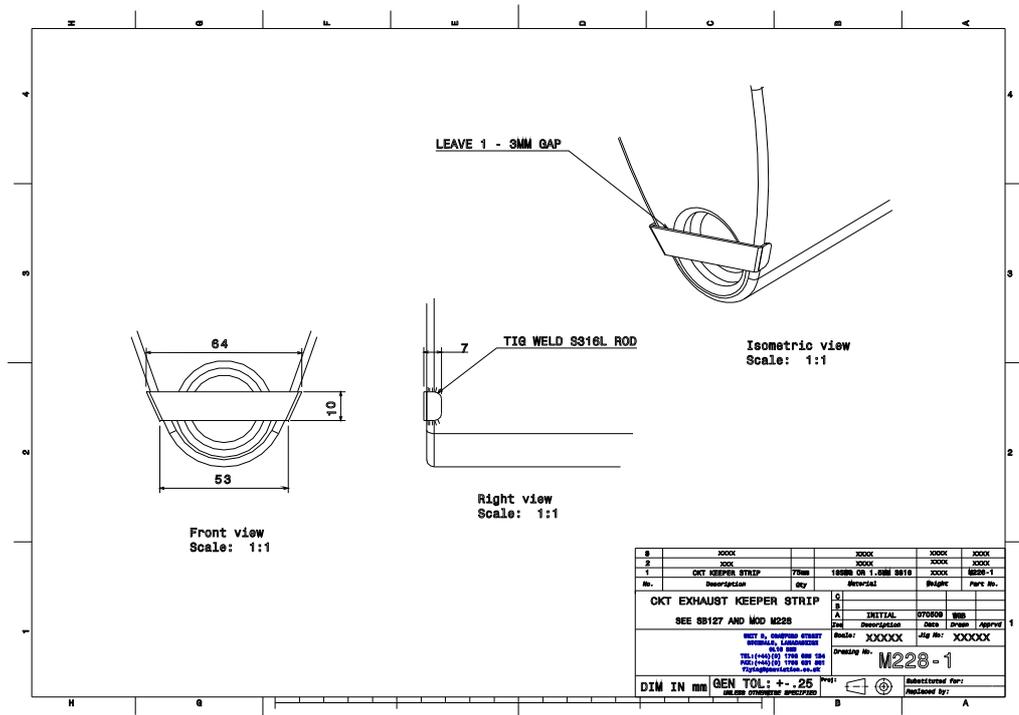
Fig 3 Exhaust Keeper modification M228

If the inner ends of the baffle tubes and internal baffles are secure, modification M228 can be carried out (see fig. 3). It provides a backup retainer if the baffle should become loose. Thoroughly clean the area. Do not use any dissimilar wire brush metals and do not mark with graphite or carbon pencils. Weld repair any cracks found using a stainless steel 316L welding rod and TIG process. Fit a 10mm wide x 18swg (1.22mm) or 1.5mm S316 strip with 7mm bent edges as shown, weld to the silencer ONLY at the corners, over the existing corner weld. The repair/modification must be carried out by a welder qualified for thin (0.9mm) stainless steel. FAA publication AC43-13-1B is a useful guide to procedures.

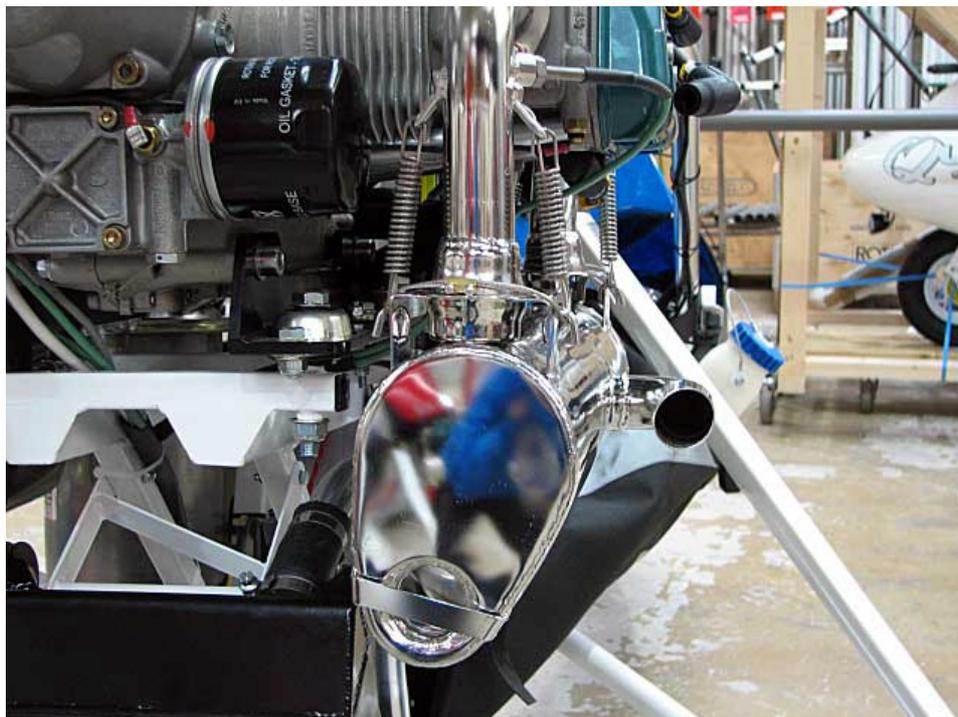
Fig 4 Exhaust springs and backup cable

- d) Apply Copaslip or similar high temperature anti-seize compound to the ball joints
- e) Refit the springs, using a cord to fit them. Rocking the can relative to the pipes may help.
- f) Refit the anti-vibration mount using 20mm washer under a new nyloc nut. Avoid twisting the rubber mount.
- g) Refit the backup cables through the springs as shown in fig 4.
