TITLE Scandal XK Hang Glider Roll Handling.

CLASSIFICATION Advisory.

APPLICABILITY Serial numbers up to 7436

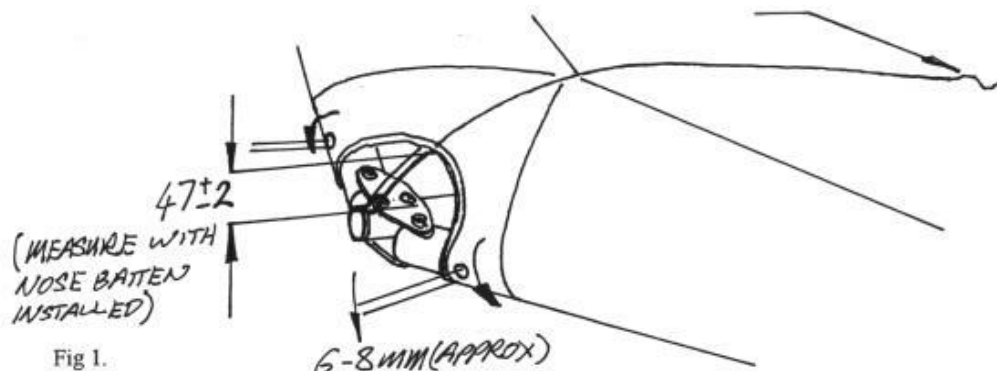
Production Scandal XK wings, especially the 14.4 size, have been reported as having poor roll control response when compared to the pre-production wings. The poor handling has been found to be because of:

The effect of this is to de-tension the wing undersurface in the chordwise direction, enabling the wing to twist more easily in response to weightshift roll inputs. At the same time, any chordwise wrinkle behind the nose batten on the top surface will be seen to reduce in size.

1) Rig the wing complete for flight. Remove the nose attachment sail screws. Remove the nose batten. Rotate the sail downwards until the gap between the top noseplate and the inside edge of the nose aperture is $47\text{mm} \pm 2\text{mm}$ as defined in fig 1. A dimension over 50mm is known to restrict roll response. Re-drill the nose attachment screws using a 3.3mm drill. This will probably be sufficient distance from the original hole to enable a second hole to be drilled; if not, contact the Factory for a replacement leading edge tube nose insert.
