US SAFETY DIRECTIVE NUMBER 132 132, ISSUE 4.

TITLE Sail reinforcement degradation additional test issue 4.

Quik, GT450, QuikR and Quik GTR with X-05 or Technora reinforcement

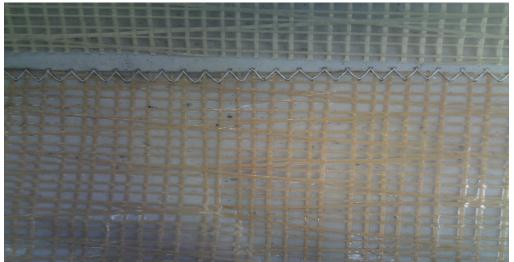
a) Aramid type X-05, which is made of yellow/gold cords woven in a cross pattern with additional diagonal cords sandwiched between transparent mylar films (see fig 1). This is the type which failed when degraded.

Fig 1, X-05 material. Top strip is new (bright yellow fibres) Bottom strip is degraded (gold/brown).

The aramid fibres start life as a bright yellow, which changes to a dull gold/brown as UV degradation develops. It may be possible to see the colour change beneath the area covered by the winglet (where fitted). The Technora is a para-aramid but dyed black to improve UV tolerance.

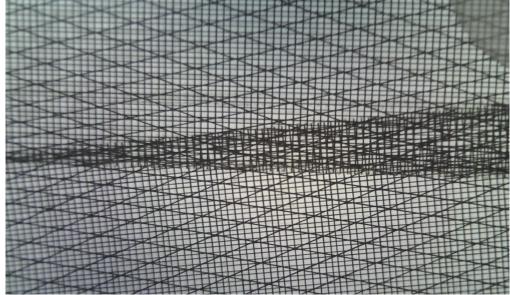
b) Technora, which is the same weave pattern as X-05 but with black cords and wider sail reinforcement strips (fig. 2). This was introduced from serial no. 8526 on.

Fig 2. Technora material

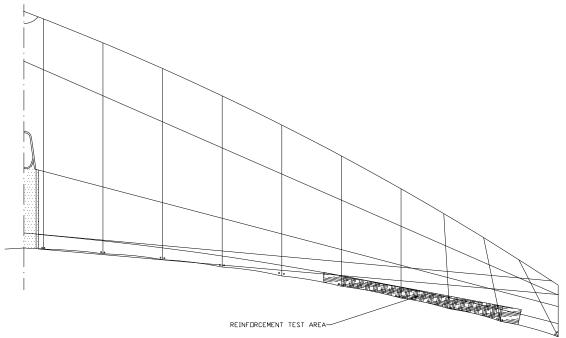
Fig 3. area for reinforcement tests

The test is to be carried out by an inspector, on 2 places on each side of the wing (a total of 4 tests), within the area shown in fig 3. The test is to be carried out with the sail un-tensioned. This can be achieved by removing the 4 tip battens in the test area to ensure no tension remains, if the wing cross tube tension is left applied.

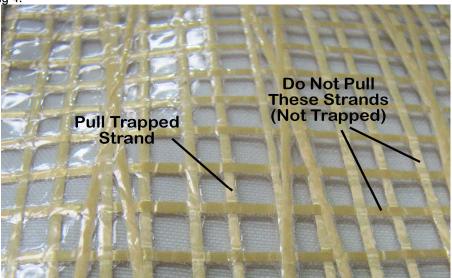
Fig 4 showing the correct strands to pull.

Look for a cord which is woven underneath nearby cords, to avoid pulling one out of the surface as

shown in fig 4.

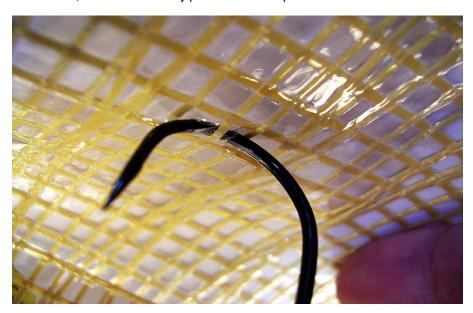
Fig 5 showing hook in position. Note adjacent strands must trap fibre being pulled.

Using an approved test instrument (consisting of a modified spring balance of 10kg capacity and a 1.5mm diameter smooth hook with a sharp point), carefully capture one cord, avoiding picking up any additional fibres from the adjoining layer. Pull away from the surface, allowing the material to fold as shown in fig 6, gradually increasing the load until the test value is reached. If the cord consistently breaks below 8kgf (Technora Black) or 9kgf (aramid yellow) load then it has failed. Care must be taken as if a cord fails, the hook will easily penetrate the Inspector's skin.

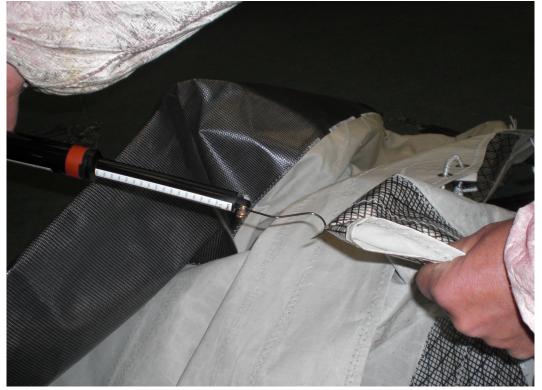
Fig 6. Hook through one spanwise cord which is woven under the surrounding cords as shown. Allow the sail to fold and grasp both surfaces. Pull gradually up to the test load as shown.
