Service Bulletin 147 - Frequently Asked Questions V1.2, 19th August 2017

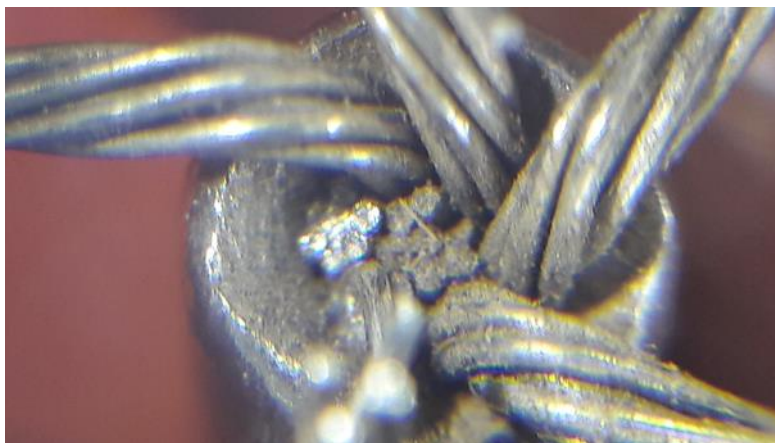
As a case in point, within the last two days, we have had 26 year old Flash 2 Alpha cables with 280 hours returned to us. The owner had recently diligently inspected the cables with a magnifying glass and no broken strands were seen. 2 weeks later a BMAA inspector found 2 external strands broken but there was no corrosion visible externally or any other damage apparent. When we cut off the cable and splayed it out, it was found that the centre core of 7 strands had all been failed for some considerable time and 14 strands from the outer cores = 21 strands failed, so max residual strength was $(48-20)/49 \times 100 = 57\%$ of new strength. Even very gentle handling of the wire caused further failures of strands.

It has now been agreed with the CAA that the Emergency Mandatory Permit Directive No. 2017-004-E will be changed to make it compulsory for all old wires to be returned to P&M for testing.
