SERVICE BULLETIN NUMBER 128 ISSUE 1

TITLE	QuikR Keel pocket webbing and flight limitations.				
CLASSIFICATION	The CAA have classified this bulletin as Mandatory.				
COMPLIANCE Inspection before further flight.					
APPLICABILITY	Webbing – up to S/N 8474 except 8370 and 8452. Flight limitations – all QuikR

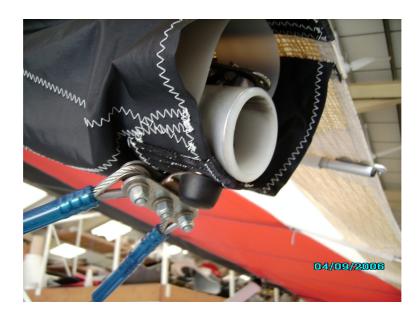
In practice for a competition well outside the certificated flight envelope (a very high g manoeuvre at a bank angle of 90 degrees and full power 110mph), a case was reported of the keel pocket rear webbing grommet pulling out. This allowed the keel pocket to move forwards approximately 30mm. No other damage was caused, there was no detectable effect on the flight characteristics and the aircraft landed safely. An example of the failure is shown below.

1)Before further flight, inspect the keel pocket webbing and ensure the grommet is in place and the keel pocket is restrained from moving forwards. If it is secure, no further immediate action is needed except 3 below. If the keel pocket attachment has been pulled out, modification M229 must be carried out before further flight and the airframe inspected for other signs of overloading (e.g. bent leading edges). The new design has a 50mm wider webbing, folded over with an internal webbing reinforcement at 90 degrees. See below, and also drawing YQE-065 issue B.
