SB 147 Cable life issue 2.

SERVICE BULLETIN NUMBER 147, issue 2.

TITLE Rigging cables with roll-swaged end terminals.
CLASSIFICATION P&M Aviation have classified this service bulletin as essential. The CAA have mandated it by means of MPD 2017-004-E.
COMPLIANCE Inspection before further flight, replacement of out of life cables within 25 hours.
APPLICABILITY Lower side, lower front and lower rear rigging cables with roll-swaged terminal ends fitted to the aircraft types below.

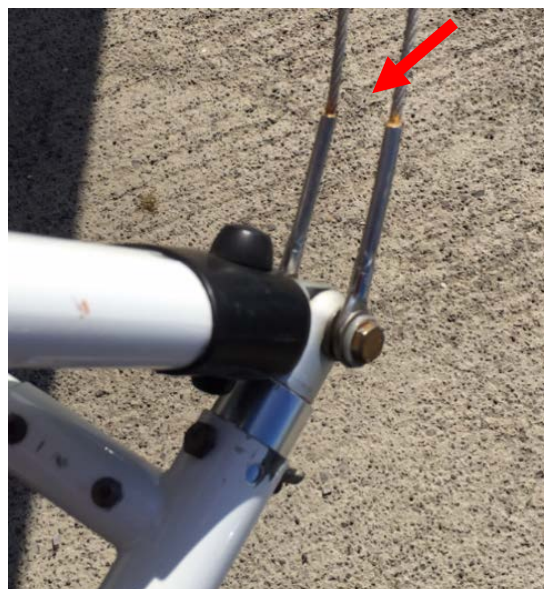
A P&M GT450 in a flying school had a partial failure of a lower side rigging cable (Part No. YQD-045) when recovering from a spiral manoeuvre, within the limits of the flight envelope. These cables are arranged in pairs, to give a backup load path. The second cable carried the load and the aircraft landed safely. This is the only P&M production lower side cable failure we have been aware of since 1984. See fig 1. for cable definitions. The partial failure was at the edge of the roll-swaged terminal end shown in fig 2. The alternative cable terminations using Nicopress sleeves and thimbles allow more progressive flexing of the cable. See fig 3.

Fig 2. Overall general arrangement of the GT450 lower side rigging cables with roll-swaged terminal ends. The arrow shows the point of partial failure. The attachment bolt at the control frame knuckle should be just loose enough to allow each cable to align with the load. Note the plating on the bolt head is shiny in this example.

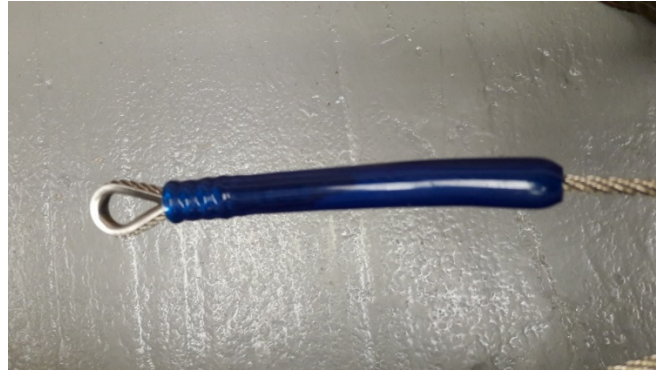
Fig 3. A thimble and Nicopress sleeve type fitting. The blue plastic shroud can be pulled back for inspection of the sleeve.

Replacement GT450 lower side rigging cables are now being provided as a kit featuring thimble and sleeve type ends and a longer control frame knuckle bolt (minor modification M313).

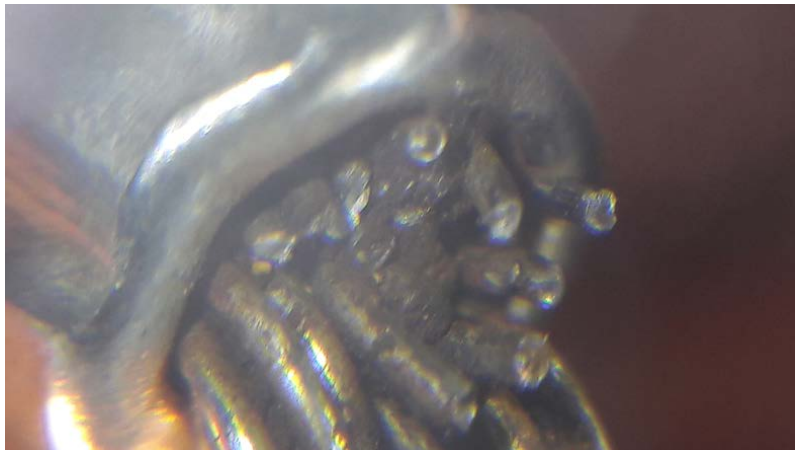
The cable fitting was at the bottom end of the cable, where solutions can wick down it and collect. The strand failures were caused by bending and tensile fatigue because of cracks propagating from scratches and corrosion pits on the surface. See figs 4 & 5.

All the remaining cables had broken strands at the edge of the roll-swaged terminals. Some of these strands had been failed for some time, as shown by discolouration of the failure surfaces. The cable is 7 cores of 7 strands construction.

The central core, being straight, can pick up more tensile load than the others and can fail before the outer ones. The broken strands are hard to spot, especially in the inner core of the cable and so it has been considered necessary to put a replacement life on structural cables with roll-swaged terminals.

Fig 4. Magnification of edge of the roll-swaged terminal of the partially failed cable. Note dirty surfaces of old failures and corrosion marks especially in the central area, which is hard to inspect externally. Several strands had been broken for some time before the failure.

For applicable cables with more than 800 flying hours or 7 years of service, whichever comes first, before further flight, visually inspect at the edge of the roll-swaged terminal(s) using a magnifying glass with a power of at least 3x. Inspect closely for damage i.e. broken strands, corrosion, mechanical damage or slippage. If any damage is found, replace the affected cable before further flight. If no damage is found, replace the cable within 25 flying hours.

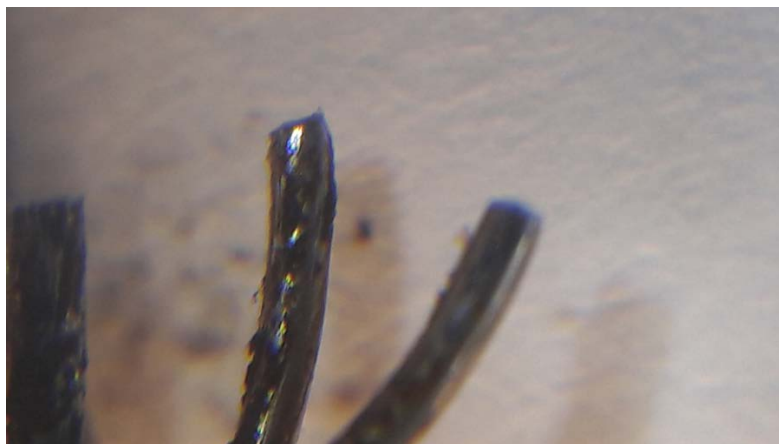
Fig 5. Failed cable strands showing wear grooves and corrosion pits.

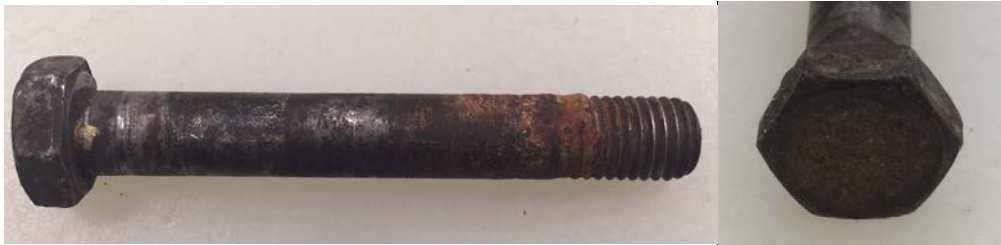
Fig 6. The corroded bolt (Part No. FBA5-21A) that held the partially failed side cable to the control frame.

As can be seen from Fig 6, this bolt displays clear evidence of corrosion and pitting. This is indicative of the general environment in which the aircraft has been operated. This also MAY be indicative of the probability of corrosion occurring within the cable itself. The corrosion on the bolt head is not uncommon for such fittings that are exposed to a salty atmosphere over a long period of time. A clean and bright bolt may well indicate corrosion of the cable is less likely to be an issue.
