SERVICE BULLETIN NUMBER 147, issue 3.

TITLE Rigging cables with roll-swaged end terminals.
CLASSIFICATION Pegasus Sport Aviation Ltd have classified this service bulletin as essential.
COMPLIANCE Cables under 800hrs/7 years old –annual inspection
 Cables over 800hrs/7 years old – in addition, special inspection and test every 2 years.
APPLICABILITY Lower side, lower front and lower rear rigging cables with roll-swaged terminal ends fitted to the aircraft types below.

SB 147 Cable life issue 3.

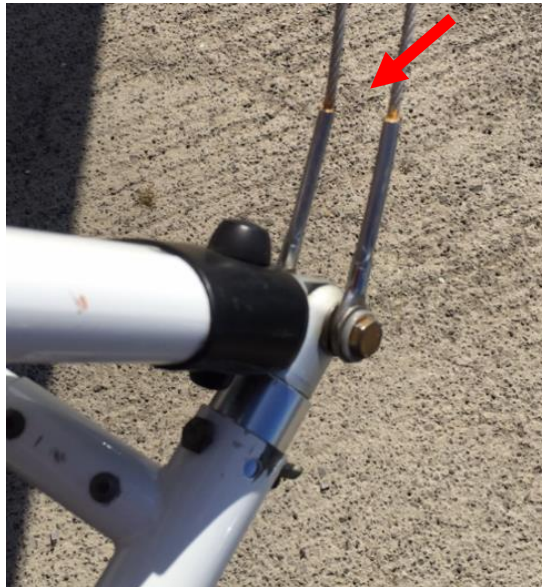
A P&M GT450 in a flying school had a partial failure of a lower side rigging cable (Part No. YQD-045) when recovering from a spiral manoeuvre, within the limits of the flight envelope. These cables are arranged in pairs, to give a backup load path. The second cable carried the load and the aircraft landed safely. This is the only P&M production lower side cable failure we have been aware of since 1984. See fig 1. for cable definitions. The partial failure was at the edge of the roll-swaged terminal end shown in fig 2. The alternative cable terminations using Nicopress sleeves and thimbles allow more progressive flexing of the cable. See fig 3.

Fig 2. Overall general arrangement of the GT450 lower side rigging cables with roll-swaged terminal ends. The arrow shows the point of partial failure. The attachment bolt at the control frame knuckle should be just loose enough to allow each cable to align with the load. Note the plating on the bolt head is shiny in this example.

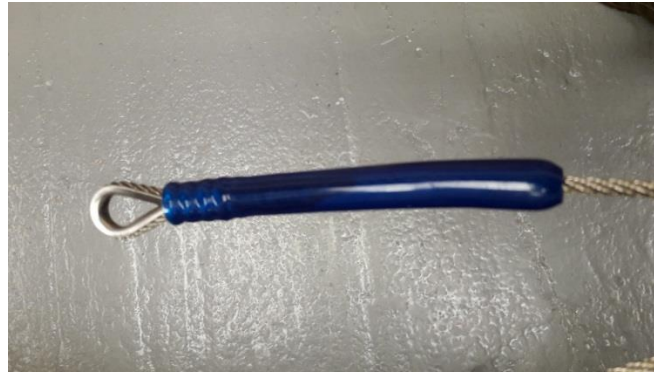
Fig 3. A thimble and Nicopress sleeve type fitting. The blue plastic shroud can be pulled back for inspection of the sleeve.

Replacement GT450 lower side rigging cables are now being provided as a kit featuring thimble and sleeve type ends and a longer control frame knuckle bolt (minor modification M313).

Note - for cables with thimble and Nicopress sleeve type ends, replacement at 800 hours/7 years is recommended *but not mandatory*, provided detailed inspection is carried out at each permit revalidation.

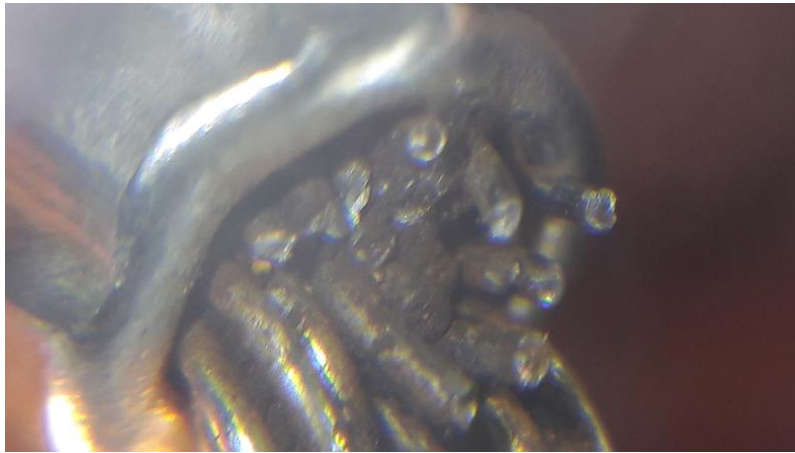
The incident GT450 lower side rigging cables had been in use for 1050 hours and 9 years. The aircraft had been subject to an accident and rebuilt once in its life. It was also operated quite near the coast where it has been considered that sea air Chlorides could have affected the material. There were corrosion pits in the S316 stainless steel material which accelerate fatigue failures. CLSCC (Chloride Stress Corrosion Cracking) is known to affect stainless steel.

All the remaining cables had broken strands at the edge of the roll-swaged terminals. Some of these strands had been failed for some time, as shown by discolouration of the failure surfaces. The cable is 7 cores of 7 strands construction.

The central core, being straight, can pick up more tensile load than the others and can fail before the outer ones. The broken strands are hard to spot, especially in the inner core of the cable. A special test and inspection has been designed to find cable damage.

Fig 4. Magnification of edge of the roll-swaged terminal of the partially failed cable. Note dirty surfaces of old failures and corrosion marks especially in the central area, which is hard to inspect externally. Several strands had been broken for some time before the failure.

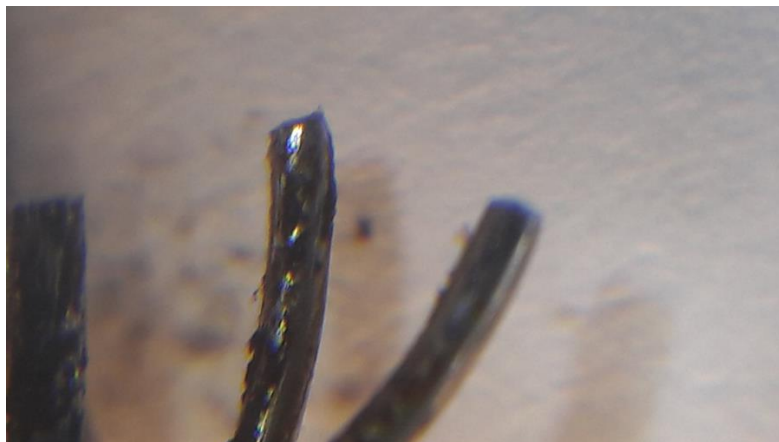
The cable fitting was at the bottom end of the cable, where solutions can wick down it and collect. The strand failures were caused by bending and tensile fatigue because of cracks propagating from scratches and corrosion pits on the surface. See figs 4 & 5.

Fig 5. Failed cable strands showing wear grooves and corrosion pits.

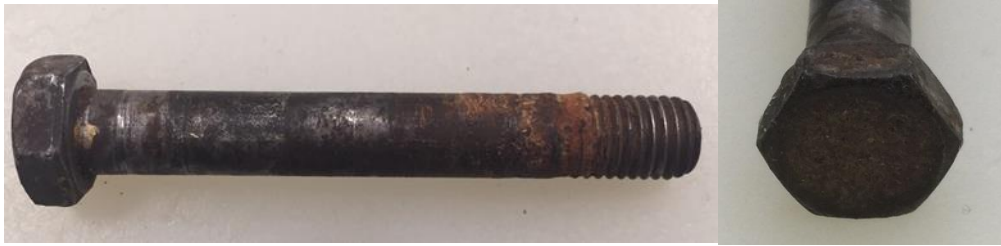
Fig 6. The corroded bolt (Part No. FBA5-21A) that held the partially failed side cable to the control frame.

As can be seen from Fig 6, this bolt displays clear evidence of corrosion and pitting. This is indicative of the general environment in which the aircraft has been operated. This also MAY be indicative of the probability of corrosion occurring within the cable itself. The corrosion on the bolt head is not uncommon for such fittings that are exposed to a salty atmosphere over a long period of time. A clean and bright bolt may well indicate corrosion of the cable is less likely to be an issue. If in doubt replace the cable.

- a) Detach the roll swaged terminal from the airframe. If the fasteners are corroded, they must be replaced.
- b) Visually inspect at the edge of the roll-swaged terminal(s) using a magnifying glass with a power of at least 3x. Inspect closely for damage i.e. broken strands, corrosion, mechanical damage or slippage.
