# Pegasus Sport Aviation Ltd.

ref: SB158 slack pull-back cable

## SERVICE BULLETIN NUMBER 158

- TITLE** Cross boom pull-back cable length and roll stability.
- CLASSIFICATION** PSA ltd have classified this bulletin as compulsory.
- COMPLIANCE** For wings fitted with the slack cross boom restraint cable modification 315 or 346 which are more than 2 years old or more than 100 hours flight time ( whichever comes first), a flight test as detailed below must be performed within the next 5 hours.
- APPLICABILITY** QuikR,(TADS BM77), Quik GTR(TADS BM80), PulsR(TADS BM81), Hyper GTR(TADS BM87) when fitted with the slack cross boom restraint cable modification M315 or 346.

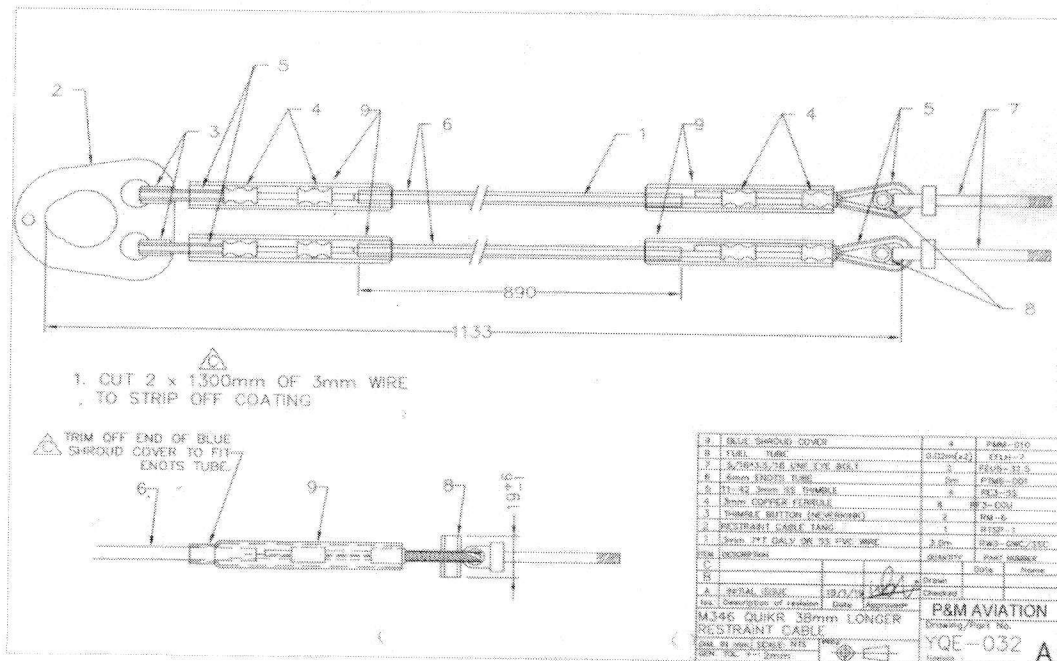
A slacker crossboom pull-back cable part YQE-032 is available for the QuikR and is 1133mm long. A slacker crossboom pull-back cable part YQF-032 is available for the GTR and is 1060 mm long. These slacker cables are approved P&M modifications no's 346 (QuikR) and 315 (GTR). They were introduced to improve roll response especially at low speeds.
