US SAFETY DIRECTIVE NUMBER 127
including

ISSUE 2

MODIFICATION M228

TITLE	CKT exhaust
CLASSIFICATION	The UK CAA have classified this as Mandatory.
COMPLIANCE	All aircraft, Inspection before further flight. At or before the next annual renewal, fit modification M228 or modified exhaust (exhaust serial number 10940809 onwards)
APPLICABILITY	All Quik, GT450 & QuikR fitted with CKT stainless steel twin exhausts. The CKT exhaust serial number is stamped on one end cover plate.

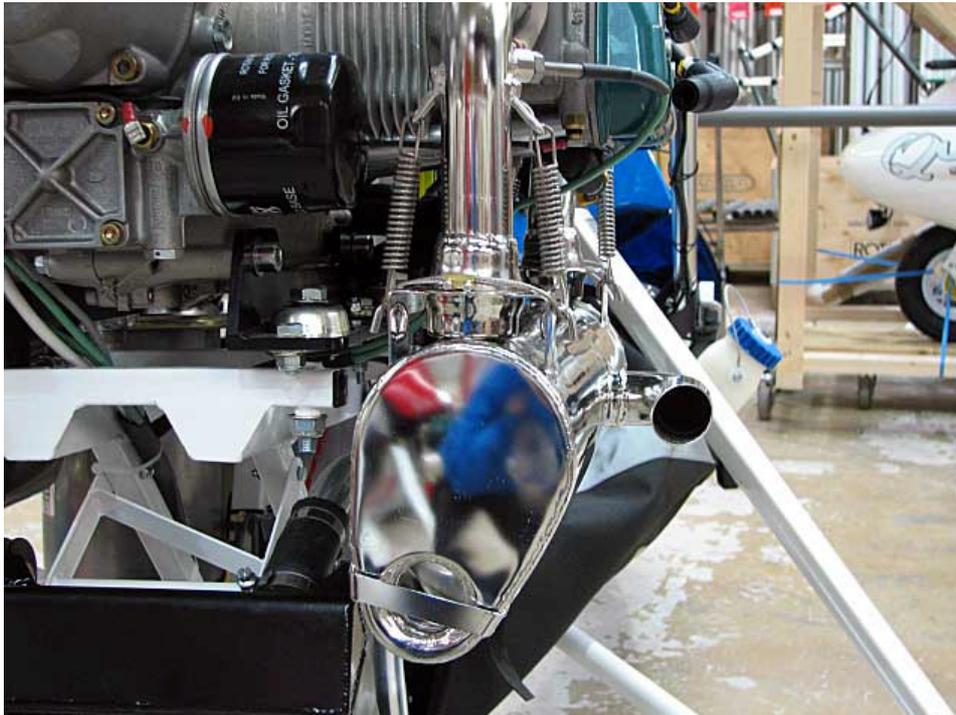
Fig 4 Exhaust springs and backup cable

Inspect the stainless steel back-up cables and springs for broken strands and wear. Inspect the rubber anti-vibration mount for cracks/disbonding. Replace with genuine P&M parts as necessary.

- d) Apply Copaslip or similar high temperature anti-seize compound to the ball joints
- e) Refit the springs, using a cord to fit them. Rocking the can relative to the pipes may help.
- f) Refit the anti-vibration mount using 20mm washer under a new nyloc nut. Avoid twisting the rubber mount.
- g) Refit the backup cables through the springs as shown in fig 4.
