SOLAR WINGS LIMITED
A Member of the Pegasus Transport Systems Group

SERVICE BULLETIN

No. 0001

Keel Tube Oversleeve
replacement.

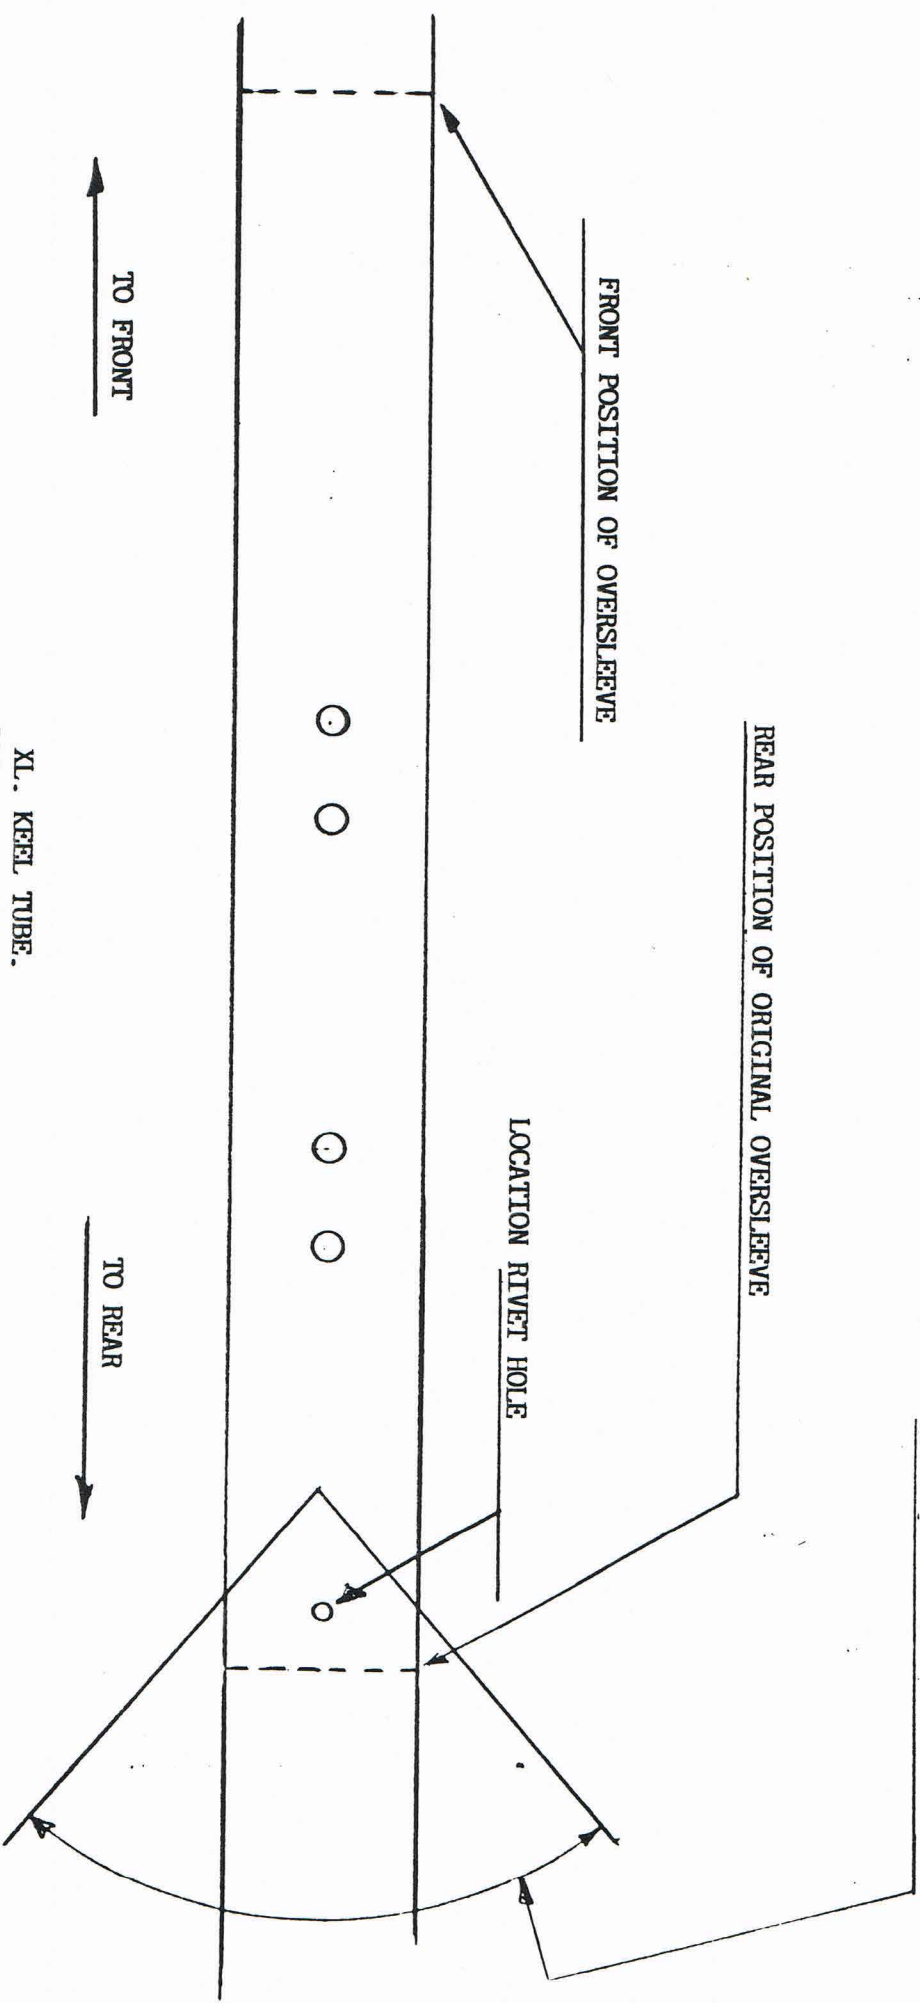
Field reports have been received of Keel Tubes being overstressed at a point to the rear of the oversleeve tube. The primary cause appears to be excessive leverage exerted during the mating of the wing and trike.

Remove Keel Tube from airframe.

Drill out Front End Cap Rivet.

Remove Swivel Channel Bolts.

Remove Suspension Plate and Nylon Bearing.

Remove Rear Retainer Ring Bolt.

Drill out and remove the oversleeve
location rivet.

Slide off the the oversleeve.

Inspect the Keel tube in the area of the
location rivet hole for signs of fatigue.

Fit new oversleeve ensuring that the King Post Spigot location hole is uppermost.

DO NOT refit location rivet.

Refit Rear Retainer Ring Bolt.

Refit Suspension Plate and Nylon Bearing.

Refit Swivel Channel Bolts.

Refit Front End Cap and secure with a retaining Rivet.

Refit Keel Tube to Main Airframe.
