| <b>TITLE</b> | Sail degradation testing and repairs. |
| <b>CLASSIFICATION</b> | P&M Aviation have classified this bulletin as Advisory. |
| <b>APPLICABILITY</b> | All P&M supported flexwing microlight aircraft. |

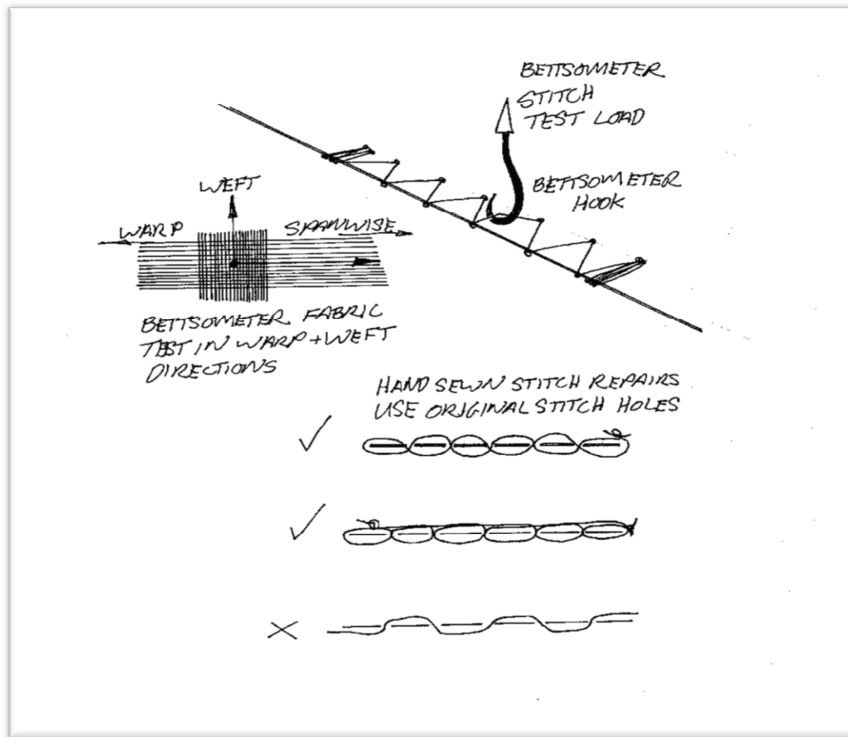
Fig 1. Cloth test, stitch test and repairs.

For test of stitching, the load is applied by passing the Bettsometer hook through a stitch and gradually applying the test load, perpendicular to the surface. See fig 1. Stitch breakage below the test load indicates the sail is no longer usable for flight.

Stitches may be repaired by hand using the original stitch holes as shown, providing they are not damaged. The maximum seam length that can be hand sewn is 150mm. Note that the stitches must be pulled tight and there must be 2 threads passing through each hole. The ends must be tied off securely. The stitch material used in current production is Gore Tenara spun PTFE, style TR, part no. M1000TR-WH-5. This does not degrade with UV light. Stitch ends must be tied off securely as it has low friction. Alternatively metric 40 nylon or V69 polyester thread may be used.

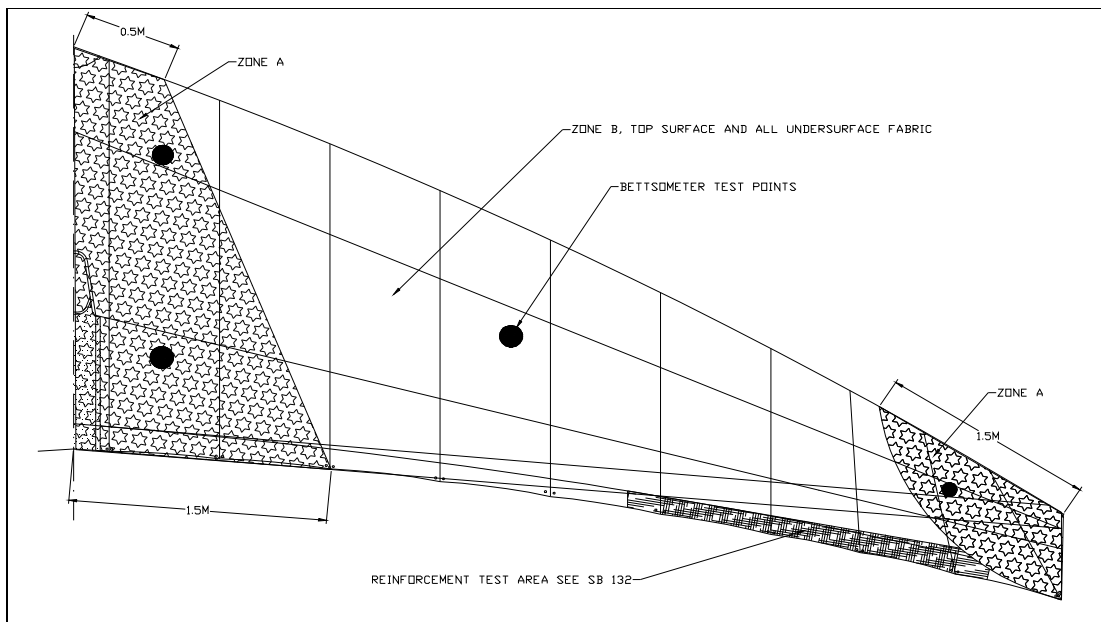
Fig 2. Test zones for the sail.

Some areas of the sail take more load than others. Depending on storage conditions some areas may degrade quicker than others. Zone A carries high loads, zone B less.

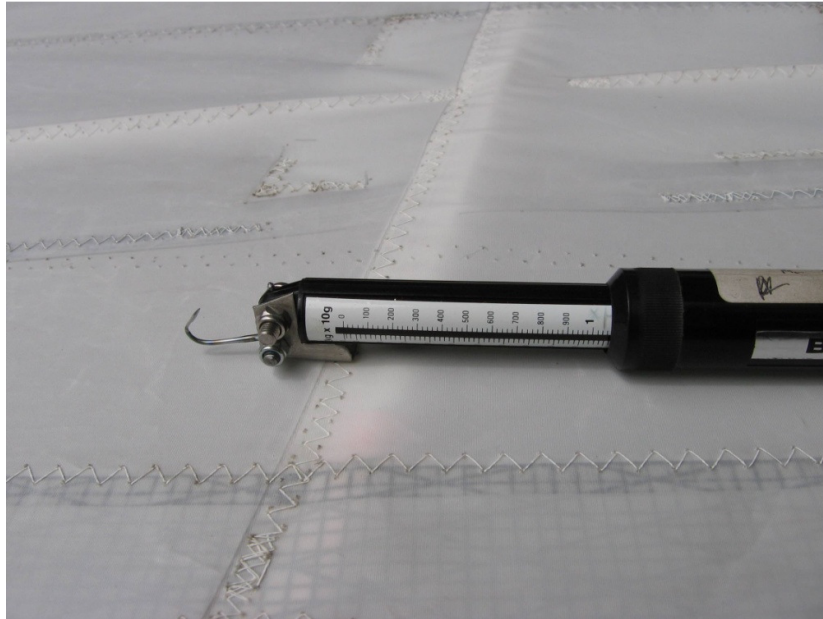
Fig 3. Bettometer test, plain sailcloth

3 types of sail fabric are used. Plain sailcloth type TNF210, plain sailcloth type TNF215 UV Coated and HTP square, which is a ripstop type weave. See figs 3 and 4.

The needle is inserted and then the test load in table 1 is gradually applied parallel to the surface, in the Warp (approximately spanwise) and Weft (approximately chordwise) fibre directions. Fabric ripping at any load up to the test load indicates the sail is no longer usable for flight.

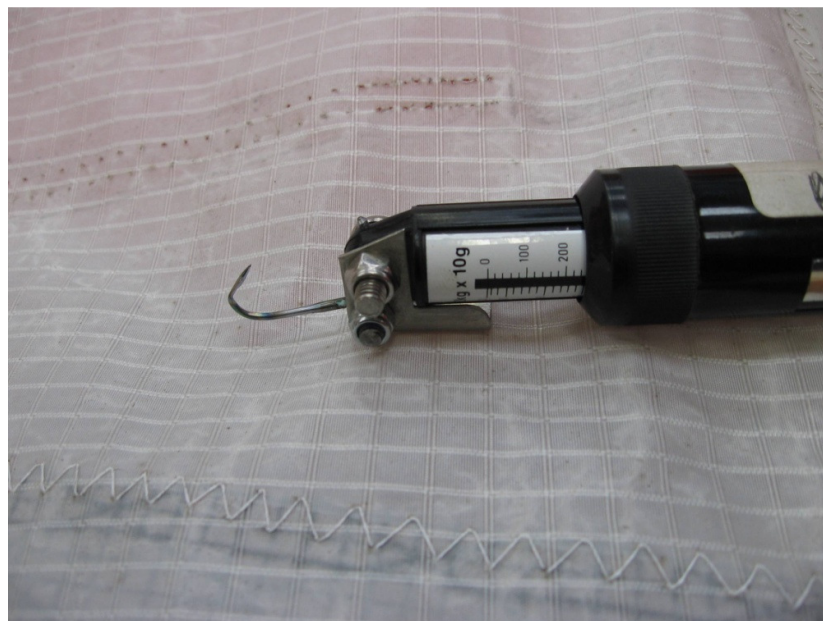
Fig. 4 Bettometer test – HTP square material, note the rip-stop weave.  
The fine fibres within each square are tested.  
Test load must not rip the small square between each ripstop cord
