15th August 2017

SERVICE BULLETIN 147 - REPLACING THE SIDE AND REAR FLYING WIRES ON A GT450 (V1.21)

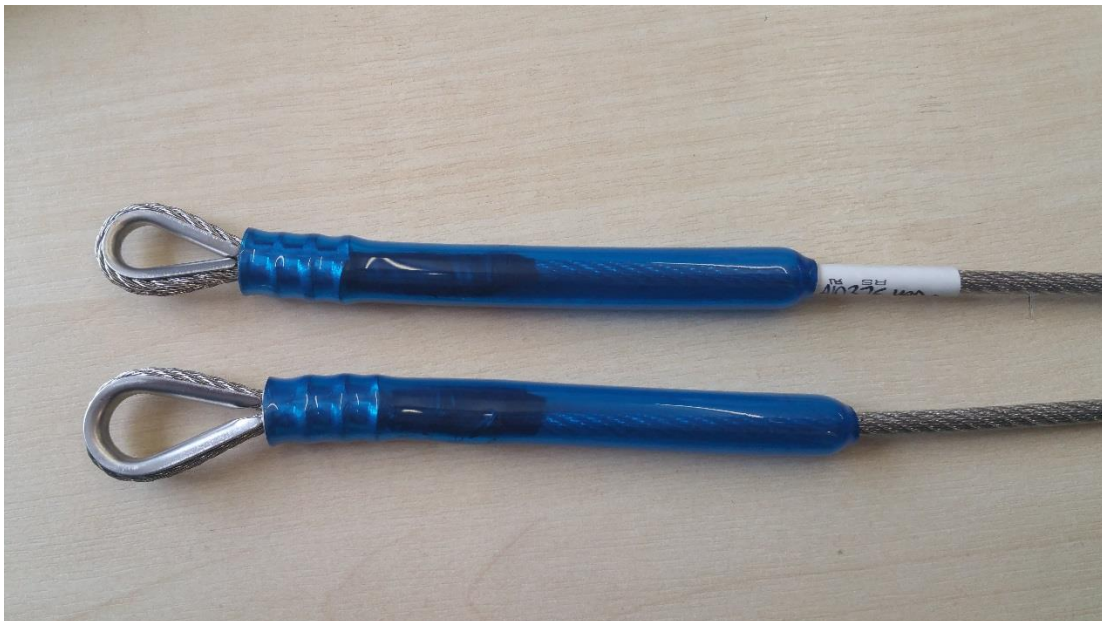
Fig 1: Difference in YQD – 045 side wire thimble sizes. The top wire with the smaller thimbles have white tag is the end is fitted to the A-Frame (where the thimbles are the same size, they may have a red paint mark to indicate the end that should be fitted to the A- frame)

The YQD - 045 wires now have smaller more compact thimbles that are fitted to the A -frame. These are physically smaller and it is the end of the cable that has the white identification tag with the part and batch nos. written on them.

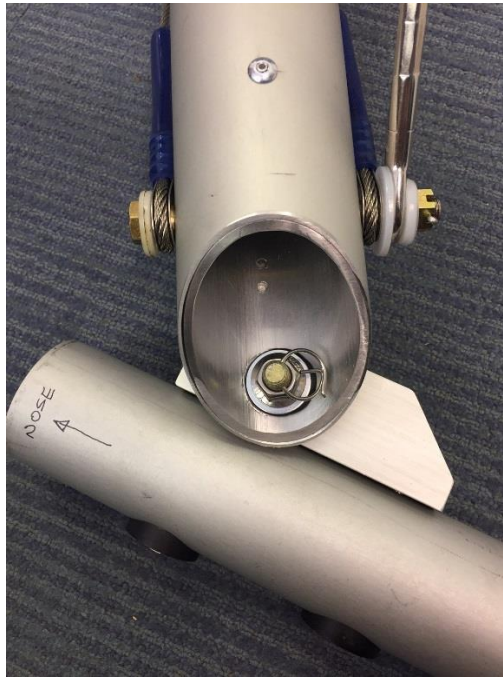
Fig 2: Note there is only one FW4-12 washer and that there are no washers between the cable thimbles and the tubing. Note also the upper rigging wire is fitted in the outer most rear position.

As part of SB 147, we have taken the opportunity to embody approved Modification 247 which replaces a number of the plated mild steel washers with nylon washers (Part Number FWP-002) in order to reduce localised corrosion issues. This is feasible as the bolts are shear loaded rather than tensile loaded here.

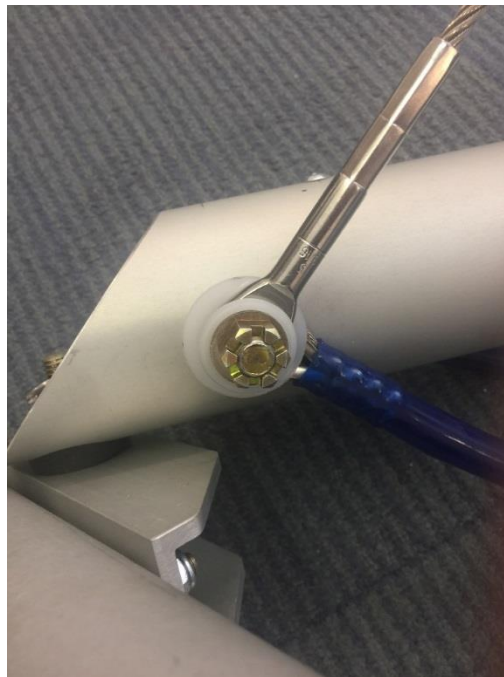
Fig 3: Detail showing the correct position of the plastic washer (Part Number FWP-002) and the optional FWM10-B thin plated washer in place (four are included in the fixing kit)

Once the split pin is fitted correctly then a skiffy cap goes over the 3/8" castle nut and split pin. Due to some tolerance build up, it may be necessary to punch a hole in the skiffy cap to achieve a fit or, alternatively, use the existing caps.

Please remember that the skiffy ring has to have the correct orientation, so that the lip is on the outside otherwise the skiffy cap will not secure.

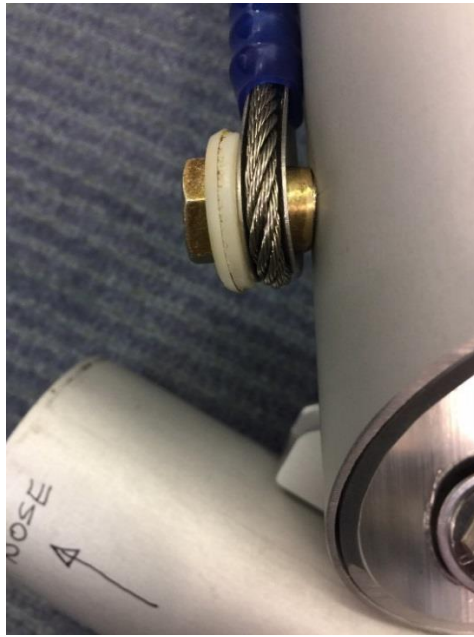
Fig 4: Shows the correct position of bush (Part No. 001-300) on the front lower rigging cable only. The purpose of the bush is to ensure equal tension in both lower side cables.

Finally, it is important to note that that the castle nut is only tightened to remove any clearances and that the bolt is **NOT** pre-tensioned.
