SB 147 Cable life issue 2.

SERVICE BULLETIN NUMBER 147, issue 2.

TITLE Rigging cables with roll-swaged end terminals.
CLASSIFICATION P&M Aviation have classified this service bulletin as essential. The CAA have mandated it by means of MPD 2017-004-E.
COMPLIANCE Inspection before further flight, replacement of out of life cables within 25 hours.
APPLICABILITY Lower side, lower front and lower rear rigging cables with roll-swaged terminal ends fitted to the aircraft types below.

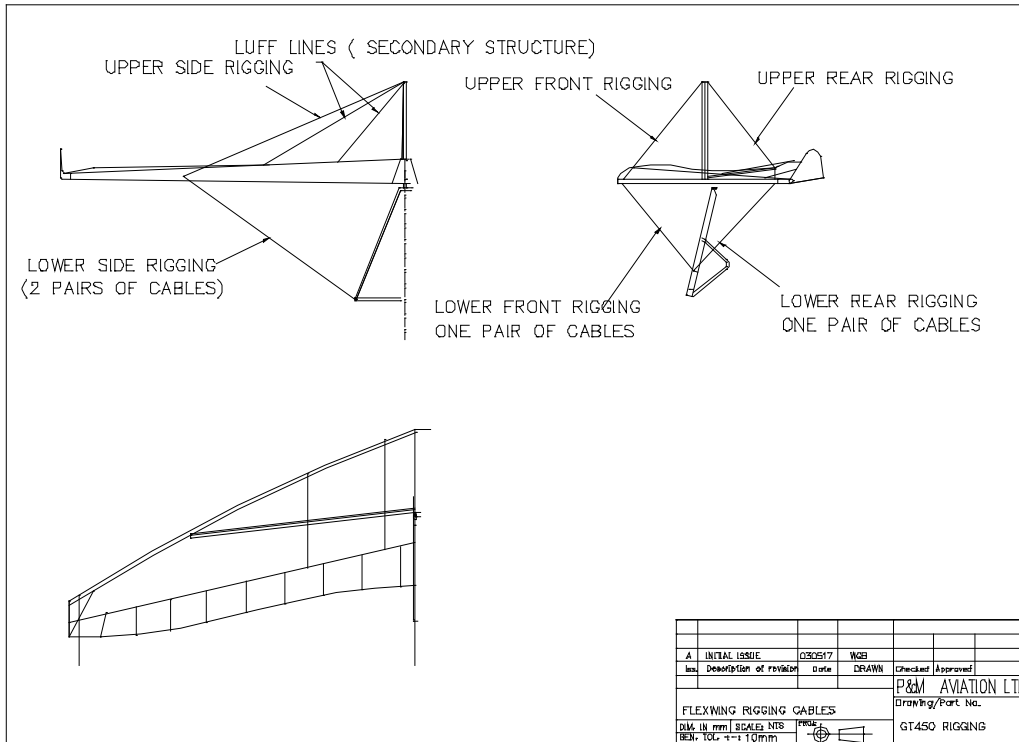
Fig 1. Structural airframe cables

A P&M GT450 in a flying school had a partial failure of a lower side rigging cable (Part No. YQD-045) when recovering from a spiral manoeuvre, within the limits of the flight envelope. These cables are arranged in pairs, to give a backup load path. The second cable carried the load and the aircraft landed safely. This is the only P&M production lower side cable failure we have been aware of since 1984. See fig 1. for cable definitions. The partial failure was at the edge of the roll-swaged terminal end shown in fig 2. The alternative cable terminations using Nicopress sleeves and thimbles allow more progressive flexing of the cable. See fig 3.
