SERVICE BULLETIN NUMBER 147, issue 3.

TITLE Rigging cables with roll-swaged end terminals.
CLASSIFICATION Pegasus Sport Aviation Ltd have classified this service bulletin as essential.
COMPLIANCE Cables under 800hrs/7 years old –annual inspection
 Cables over 800hrs/7 years old – in addition, special inspection and test every 2 years.
APPLICABILITY Lower side, lower front and lower rear rigging cables with roll-swaged terminal ends fitted to the aircraft types below.

SB 147 Cable life issue 3.

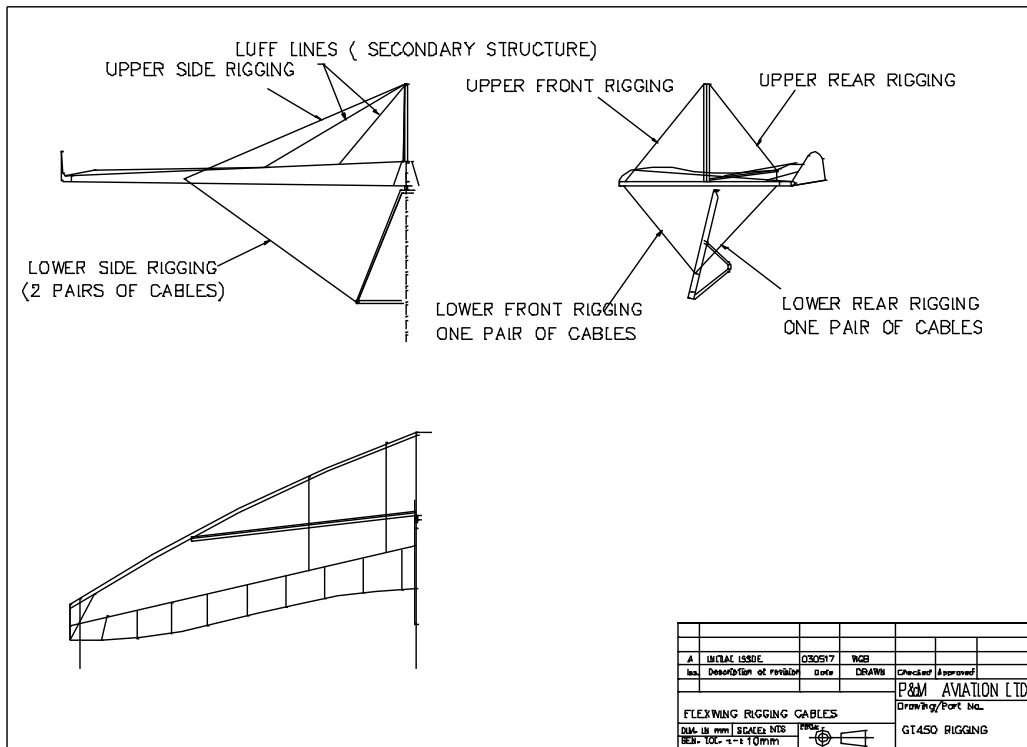
Fig 1. Structural airframe cables

All the remaining cables had broken strands at the edge of the roll-swaged terminals. Some of these strands had been failed for some time, as shown by discolouration of the failure surfaces. The cable is 7 cores of 7 strands construction.

The central core, being straight, can pick up more tensile load than the others and can fail before the outer ones. The broken strands are hard to spot, especially in the inner core of the cable. A special test and inspection has been designed to find cable damage.
