**TITLE** Oil cooler to tank suction hose joint (oil cooler end), incorporation of minor modification M126, hose clamp wire locking.

**APPLICABILITY** All Pegasus Quik and Quantum with Rotax 912 and 912-S engines, up to serial number 8074 (before 02/09/04).

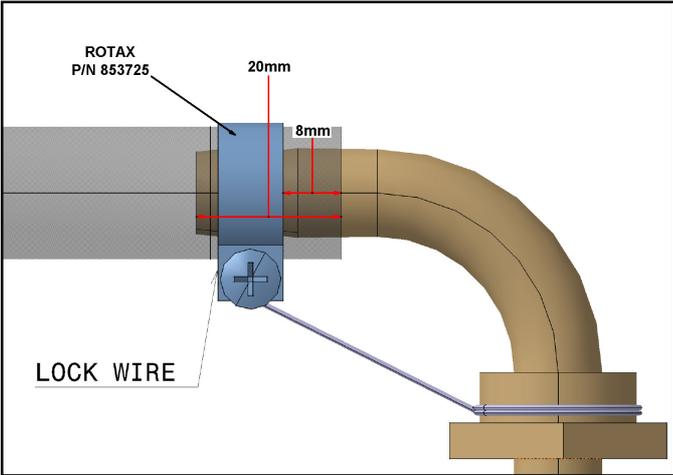
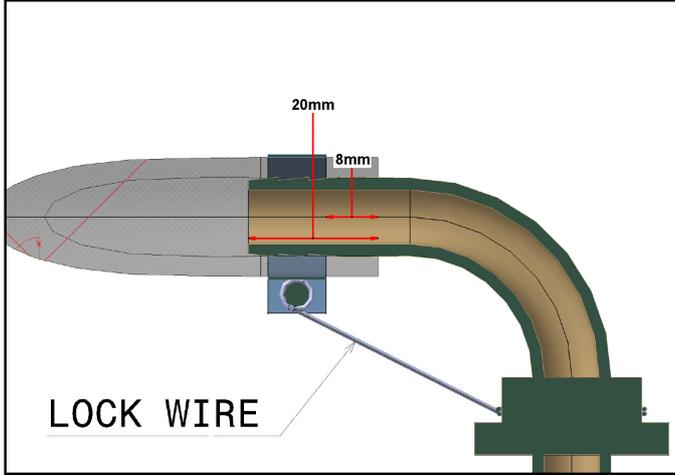
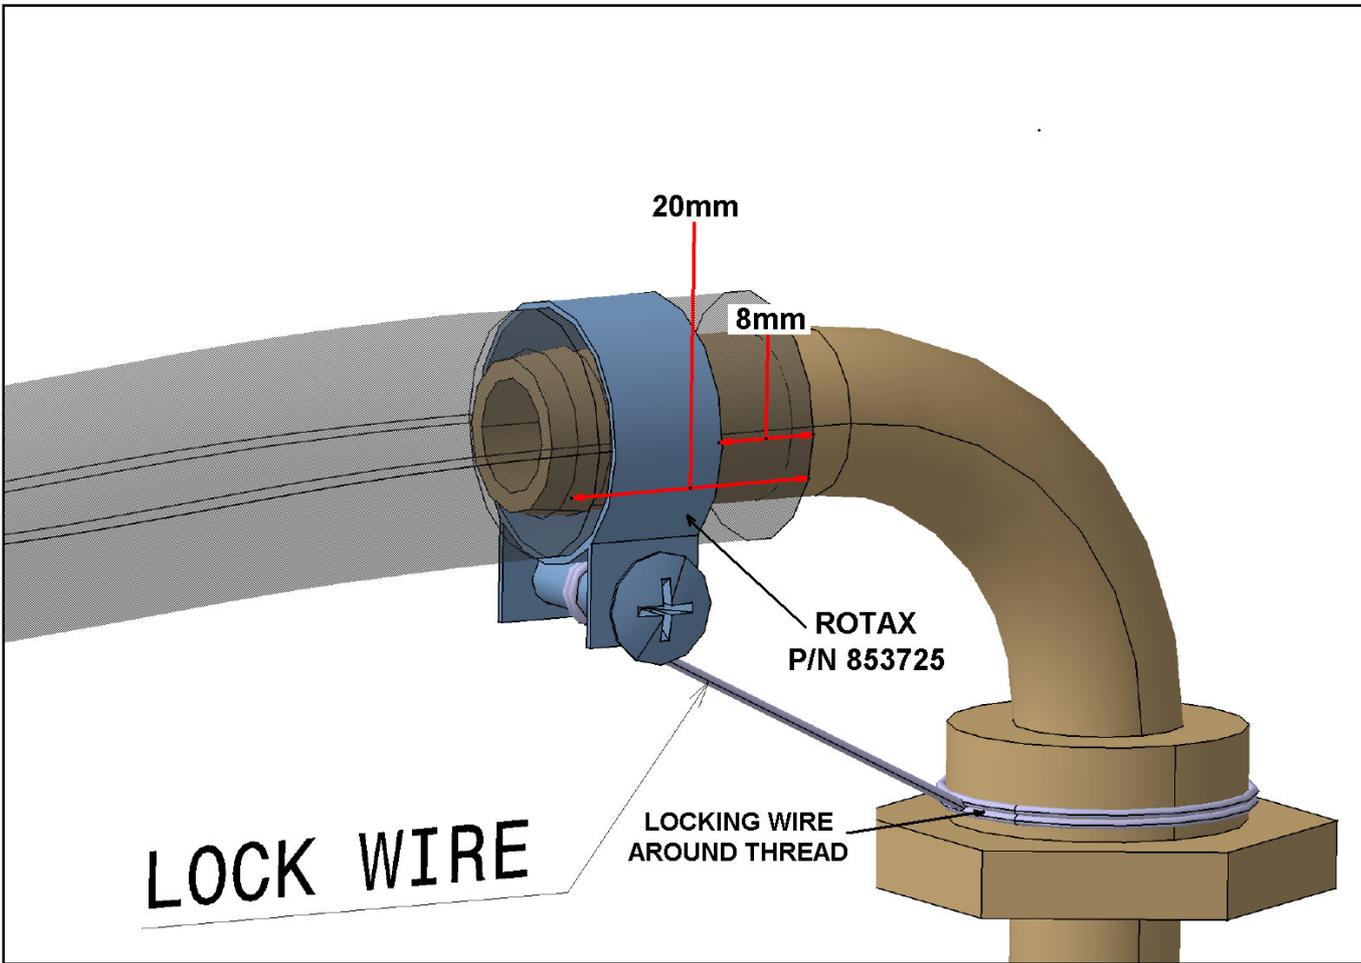
The ROTAX supplied 90 degree oil cooler fitting (part no. 924583), has barbs on it which are intended to prevent the hose moving once clamped in position. The barb profiles on recent fittings appear to have been partially machined down from a sharp rear edge to a truncated profile which gives less security. If the hose is not pushed on far enough and the hose clamp is not positioned correctly over the barbs, the hose may loosen. Further tightening of the clamp may actually squeeze the hose off the fitting.

- 1) Remove the hose and clamp. Check the hose and fitting are undamaged and that the hose clamp is suitable for this application (ROTAX original part number is 853725)
- 2) Degrease the hose and fitting with acetone or petrol, being sure not to get rag etc. lodged in the oil cooler or hose.
- 3) Make a felt tip pen mark, 20 mm from the end of the fitting. Push the oil hose onto the fitting up to the felt pen mark.
- 4) Position the hose clamp 8 mm back from the hose end, to ensure correct positioning of the clamp over the barbs as depicted in attached drawing. Tighten the clamp.
- 5) Wire lock the clamp to the threads on the oil cooler as shown. (monal locking wire)
