SOLAR WINGS LTD

SERVICE BULLETIN

no. 0027

Fuel Tank Sealing

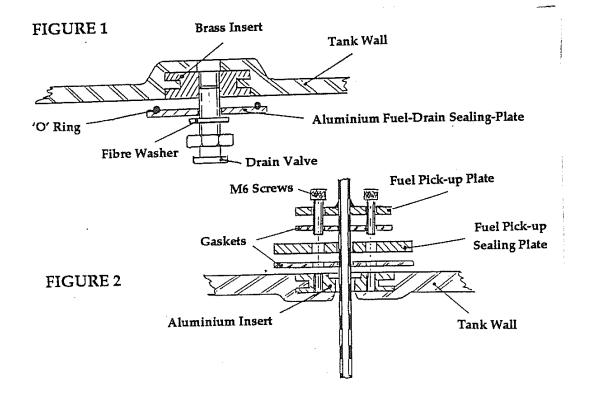
Leakage from the fuel tank inserts for the fuel drain and the fuel feed on some Quasars up to serial no SW-TQ-0031 has been reported. After no. SW-TQ-0031 the design of both inserts was changed so that the sealing action is by direct clamping to the tank wall.

If leakage is discovered at the fuel drain, ensure that the valve itself is sealing properly. If the insert is at fault, then the leakage can be prevented by installing a fuel drain sealing plate and "O" ring between the drain valve and the tank. (see fig 1.)

Leakage at the fuel pickup plate should again be investigated to ensure that the insert is at fault. If so, a sealing plate and gasket system can be installed as in fig 2.

Hylomar gasket sealing compound can be used sparingly on the gaskets, but SILICONE SEALANTS MUST NOT BE USED as they break up in the presence of fuel, with the consequent risk of blockage.

Fuel tank drain or fuel tank pickup sealing kits are available from the factory.
