SERVICE BULLETIN no. 0083

Three Sheave Luff Line Pulley on Q2 Wings

12 Quantum Q2 Wings. These wings will have serial numbers: 7104 to 7122.

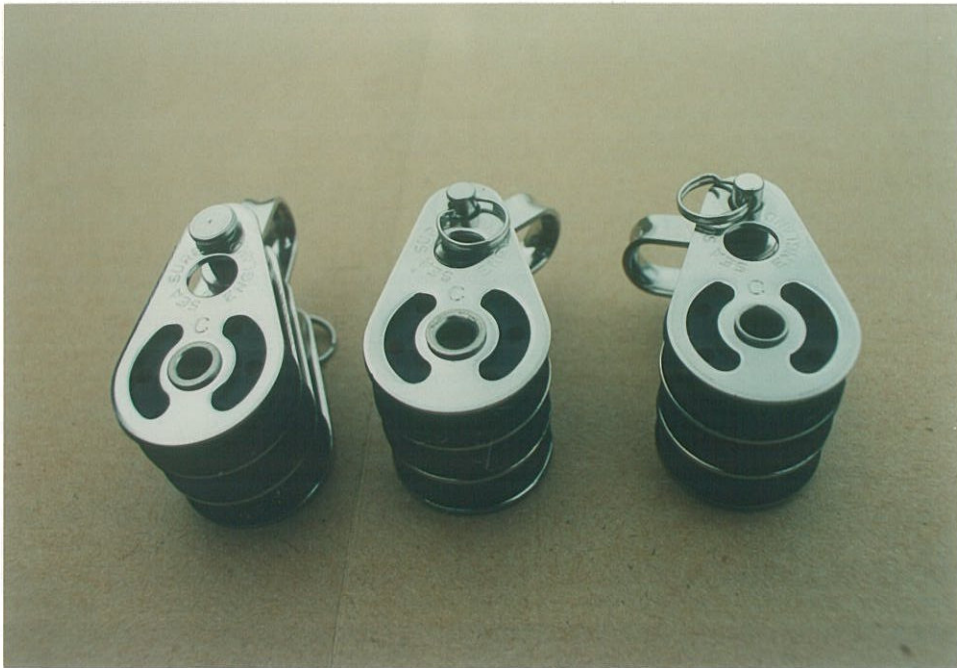
Fig 1:

It has been noticed from a factory inspection that a batch of pulleys made by Sea Sure may be defective. The three sheave luff line pulley block concerned is located at the top of the king post. The tube which holds the pulley rings together is machined one end and peaned the other, the three sheave pulleys of this batch are not all correctly peaned. A photo of three pulleys is shown in Fig. 1., the pulleys to the left and middle of the picture show the machined end and a correctly peaned tube respectively, the pulley shown to the right has been peaned with insufficient pressure which may cause it to fail under constant use.

Before the next flight it is required that the owner of the Q2 wings described above should contact Cyclone Airsports Ltd at Manton, Marlborough, where a replacement pulley will be fitted on inspection. Alternatively phone or fax Cyclone Airsports Ltd to order a replacement part free of charge. Fitting instructions will be given on request. Tel: +44 (0)1672 861578 Fax: +44 (0)1672 861550.
